STUDY CASE N° 22: RETRIEVAL OF A FIRE DAMAGED GAUGE CONTAINING A RADIOACTIVE SOURCE

European ALARA Newsletter: Issue 21

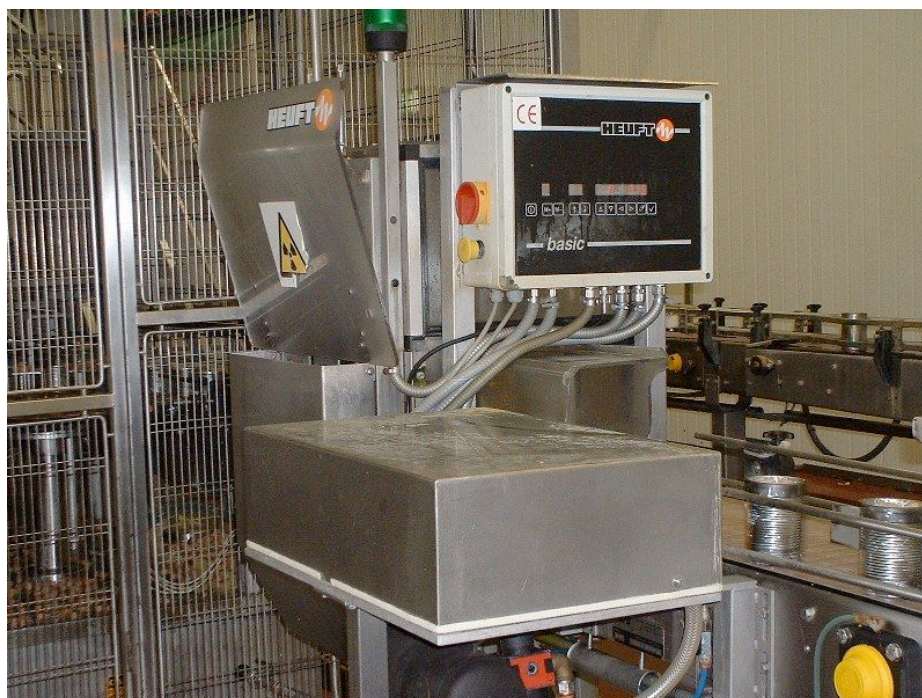
The gauge formed part of a Heuft fill-height detection system (Model – Basic 4) (Figure 1) and it contained a 1.67 GBq Americium-241 (Am-241) source. The system was used on a production line as part of a quality control process to determine the volume of contents in metal cans. The Am-241 source and the associated radiation detector are contained within a ‘bridge unit’.

Figure 1. Heuft fill-height detection system (Model Basic 4) on the production line of the plant (pre-fire)

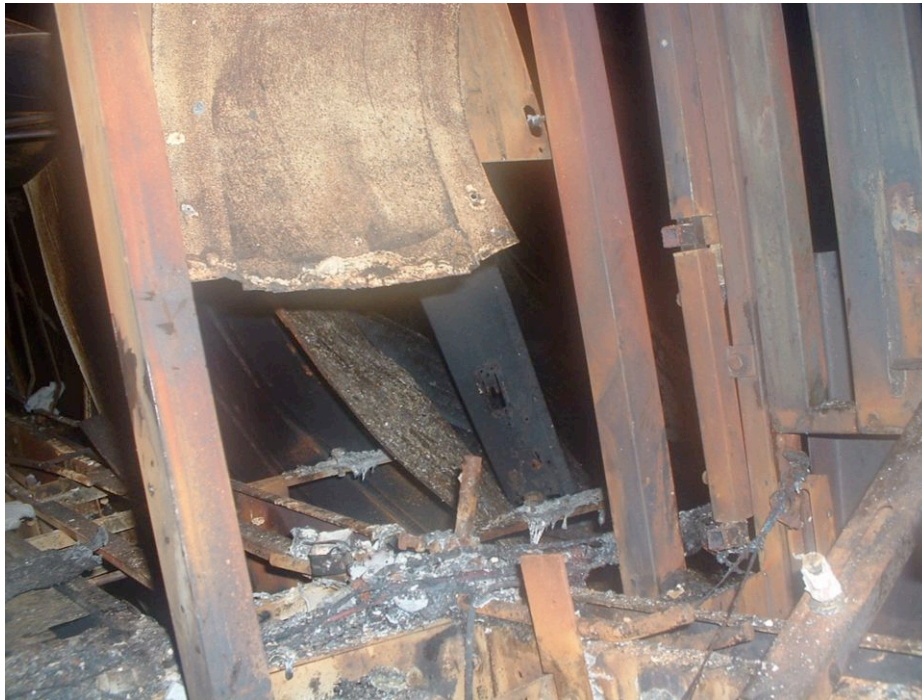
Figure 2. Portion of galvanised sidewall that was cut through by fire crew to facilitate access to the production line area

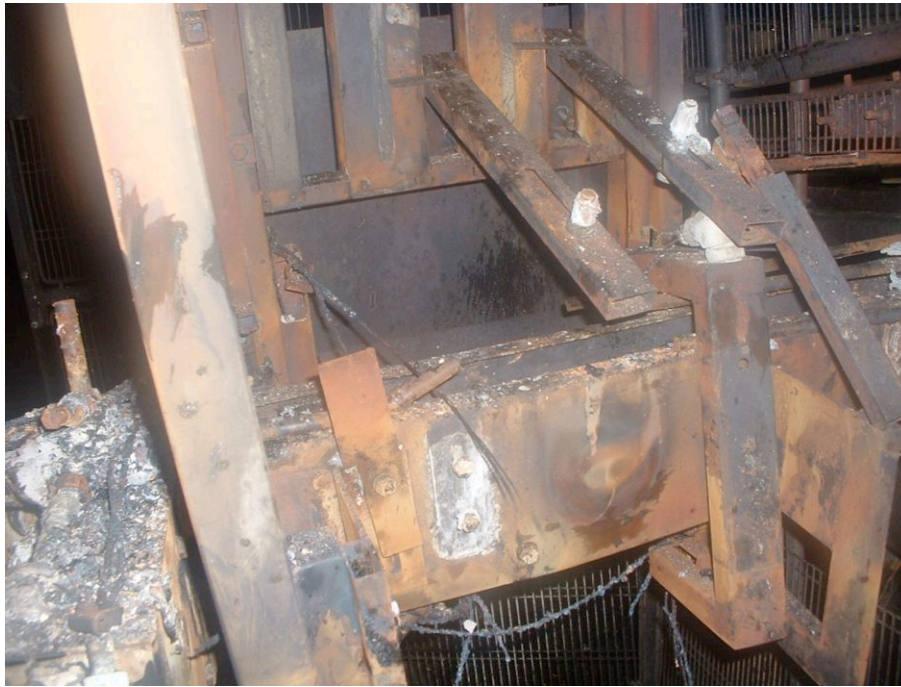
On entering the production line area the remnants of the fill-height detection system were identified (Figure 3). The environment in the area around the remains of the level system was completely destroyed and the array of galvanized metal and debris made access and working conditions very difficult. The bridge unit was located at the base of the fill height detection system. As no dose rates above background were detected using the hand held instruments the bridge unit was removed by a fire officer for closer inspection (see Figure 4).

Figure 3. Remnants of the Heuft fill-height detection system

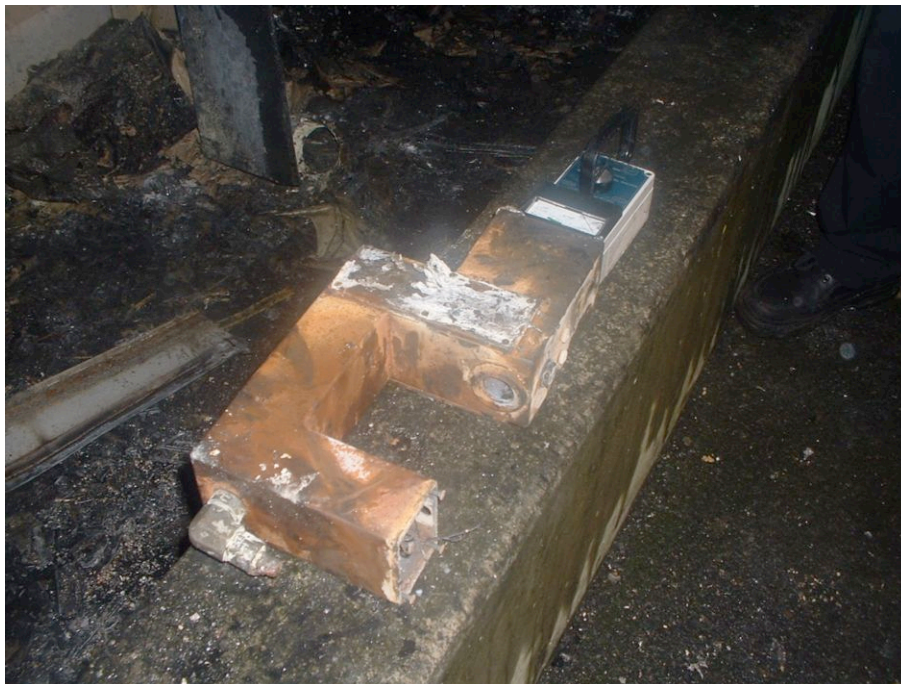
Figure 4. Damaged bridge unit being surveyed outside the building

Given the damage to the unit it wasn't possible to confirm the presence of the source and it was considered necessary to send photographs (Figure 4) to the manufacturer in England

(Heuft UK) for their assessment of the bridge unit. Heuft UK advised that the source block was missing from the bridge unit and provided a description of the source block to facilitate the recovery operation.

However, this incident has identified one potential flaw in the safety design of this model of Heuft fill-height gauge. The mounting plate which holds the Am-241 source block inside the bridge unit is made of aluminium, and during this fire the mounting plate melted which resulted in the source block detaching from the bridge unit and falling out onto the floor.

The metal radiation warning labels riveted to the outside of the bridge unit were also destroyed in the fire. These labels were subsequently found to be located on the detector end of the bridge unit rather than the source end.

The manufacturer, the RPII and other licensees with a similar fill-height detection system have consulted on the findings of this incident and the aluminium mounting plate in all units has been replaced by one made of stainless steel. Heuft UK has also indicated that all fill-height detection systems being currently manufactured now have a stainless steel mounting plate.

The question of fire proof radiation warning labels and engraved trefoil signs is being pursued by Heuft UK.

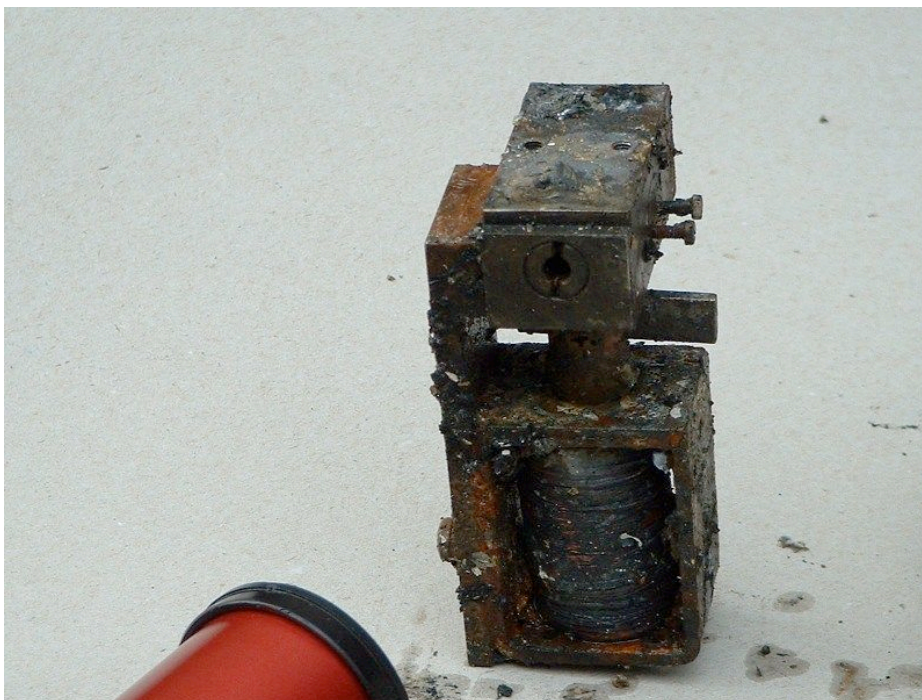
Figure 5. Front view of the recovered component which included the source block containing the Americium-241 source.

The component was removed from the building for further examination. A dose rate of approximately $10 \mu\text{Sv/hr}$ was detected at the front face, and approximately $2\text{-}3 \mu\text{Sv/hr}$ at the rear face, and it was therefore assumed to be the missing source housing. On further inspection the shutter mechanism was identified and, although loose, it was confirmed to be

closed. Wipes were taken of all exposed surfaces. No contamination was found on the wipes using the contamination monitor. The wipes were subsequently given to the RPII Measurement Services for analysis, which confirmed that there was no contamination present and therefore no leakage from the source had occurred.

With the component pointing away from all personnel the RPII Inspector opened the shutter with a long handled tweezers and the measured dose rate reached approximately 200 $\mu\text{Sv/hr}$. This confirmed that the recovered component was in fact the Am-241 source contained within its protective housing

The metal source block and the metal bridge unit used by Heuft in this model of fill-height gauge are very robust as they survived a significant fire (estimated to be greater than 1000 °C for several hours), and prevented any leakage or contamination of the source.

The shutter was fixed in a closed position and the component was put in a secure metal container. This container was labelled as containing radioactive material and placed in secure storage on site along with the previously recovered bridge unit. Dose rates around this container were less than 1 $\mu\text{Sv/hr}$.
