Industrial radiography incidents in Norway 2014

Sindre Øvergaard, Bjørn Helge Knutsen, Gunnar Saxebøl

Berne, 15.03.2016

Statens strålevern
Norwegian Radiation Protection Authority

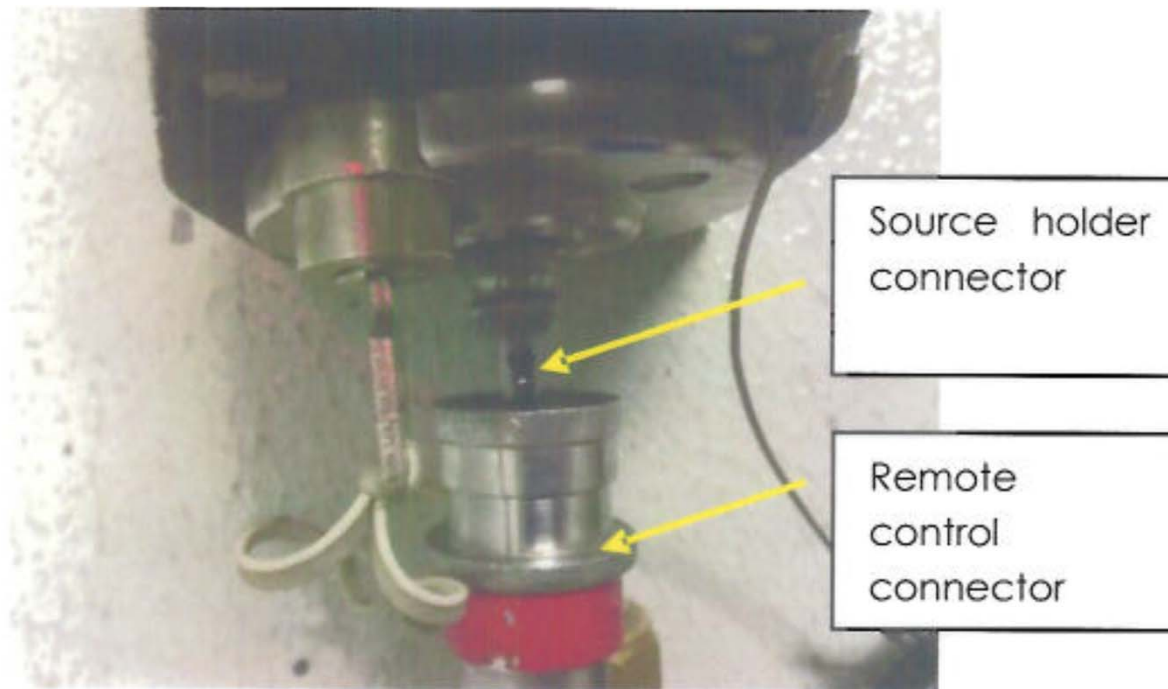
Picture 1

- Not possible to lock the radiography container
- Source holder was fully retracted, but the source was still in the collimator

- Notification procedures in the contingency plan was followed.
 - RPO and NRPA was notified.
- Adequate emergency preparedness equipment was available.
 - The source was covered with lead.
- The collimator was replaced with an end piece who fitted the emergency container. The source was cranked into the emergency container and returned to the distributor.

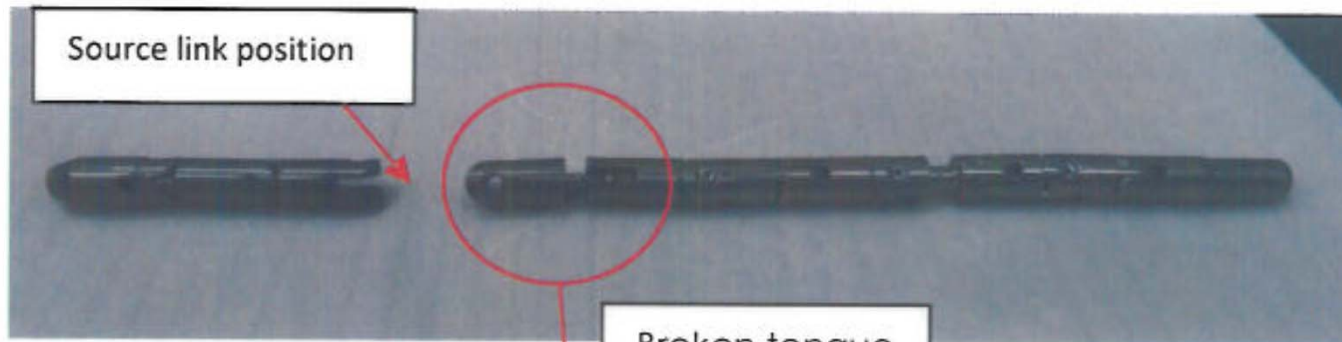
Picture 2

- A link in the source holder was broken

- The breakage occurred at the level of the tongue of the first link located after the source link

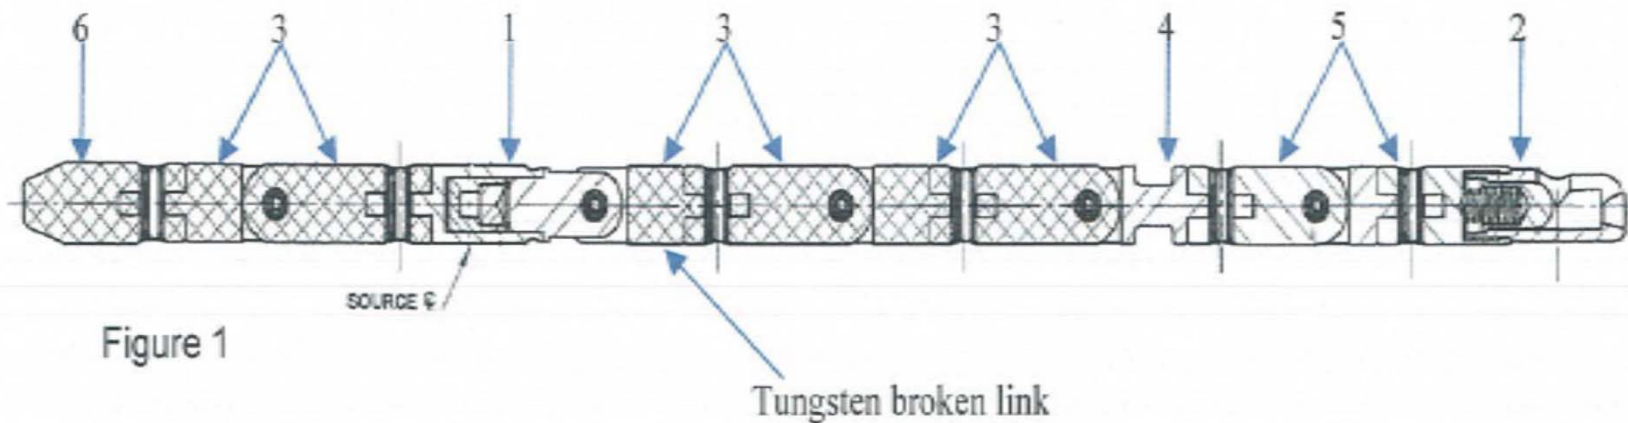
1. Se-75 source link: external envelope Stainless steel
2. Female connector: Stainless steel
3. Shielding links: Tungsten minimum density 17g/cm^2
4. Stainless steel link
5. Stainless steel link
6. End link: Tungsten minimum density 17g/cm^2

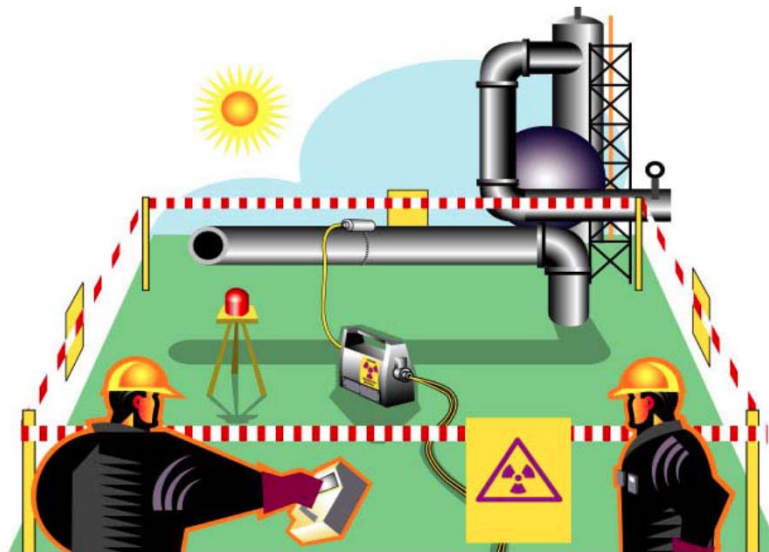
- The incident – “symptoms”: Not possible to crank the source back to the radiography container after exposure

- A mix between different generations of remote controls and drive cables was used during the incident.
- There exists two versions of the GammaMat remote control and components that are not interchangeable.
- The remote control must be assembled from only version 1 components or only version 2 components.

- With the mix of components, the remote control was properly attached to the radiography container, but the source holder could not be properly attached to the drive cable.
- Consequently, it was possible to push out the source, but the source came off the cable when trying to reel it back in.
- The fundamental cause: communication failure between manufacturer and distributor regarding the importance of not mixing components.

- Procedures have been changed to make sure it will not happen again.
- The distributor checked their records looking for remote controls where the drive cable had been changed, but found none.
