# ALARA learnings of the lost radioactive source in the West Australian outback

Frank Harris Chief Advisor Radiological Governance

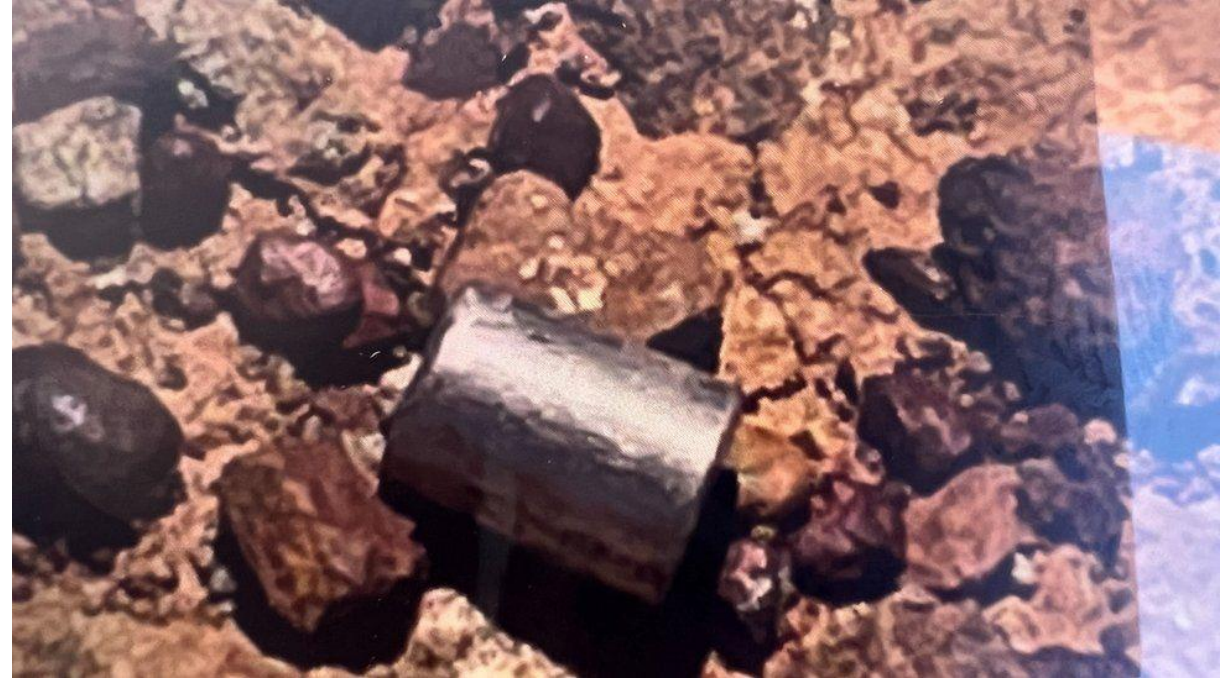
# FOUND!!!!

- The lost source capsule was found approximately 2m off the edge of a road in a remote area of the Australian outback
- The gauge had only travelled approximately 160km from the point of origin before the capsule was lost
- The source capsule recovery represented a great result of State and Commonwealth government agencies
- The source capsule remained fully intact with no release of material from the double encapsulation
- Dose estimates confirm no individual received a radiological exposure even a small fraction of the public dose limit or even the levels from annual exposure to natural background radiation

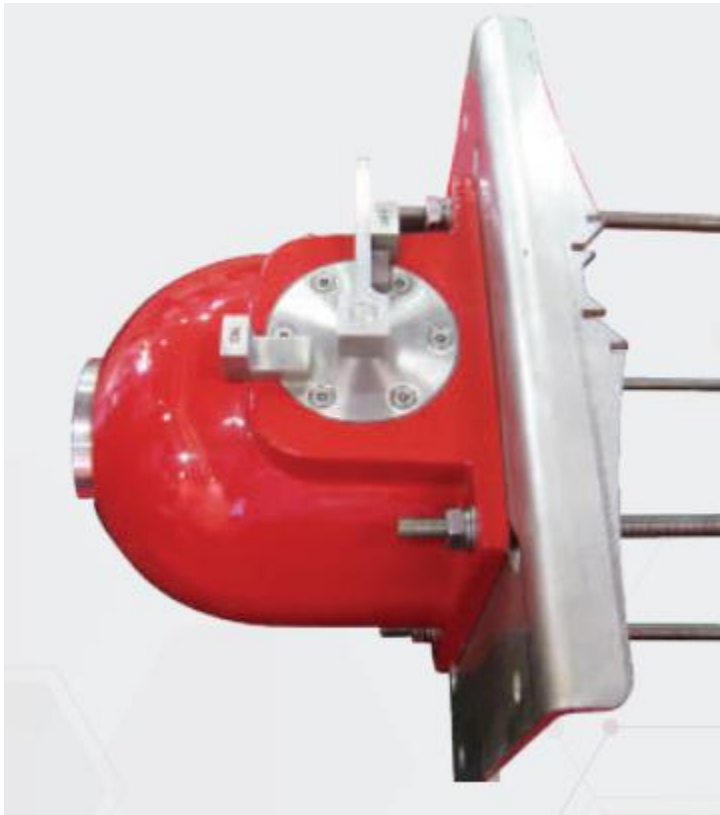
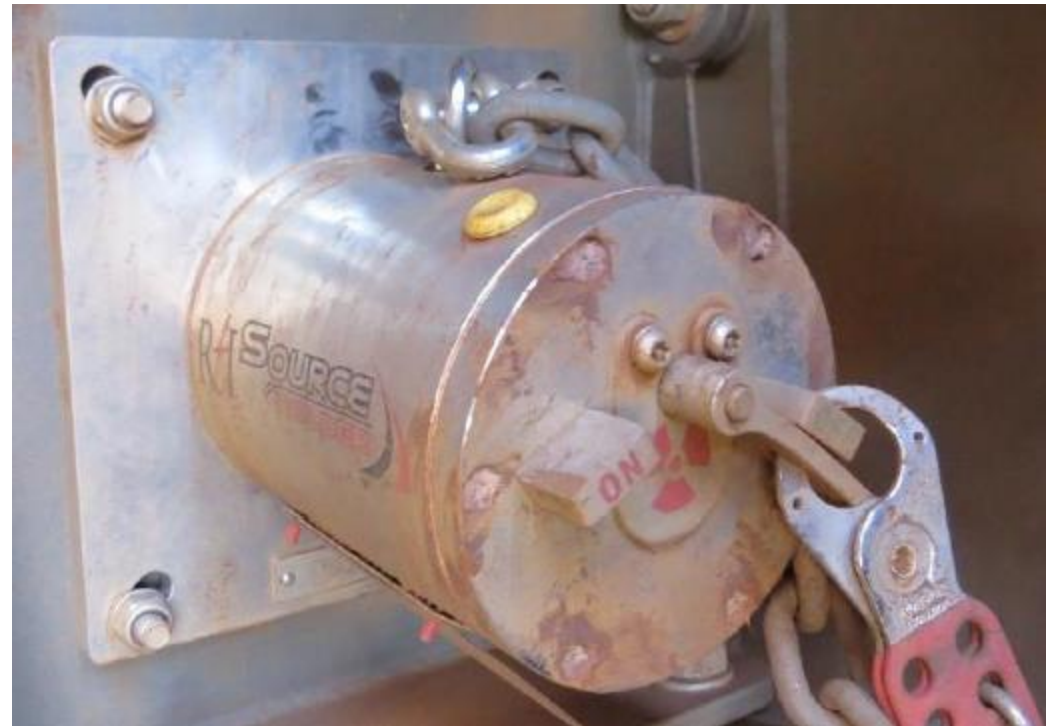
# Old vs New – Progress is not always a good thing

- The “new” gauge designed moved from the historic cast construction to an engineered structure with the outer casing consisting of a cylinder attached to a front and back end plate
- The structure is supposedly held together by 12 M5\*16mm bolts (6 at the front and six at the back)

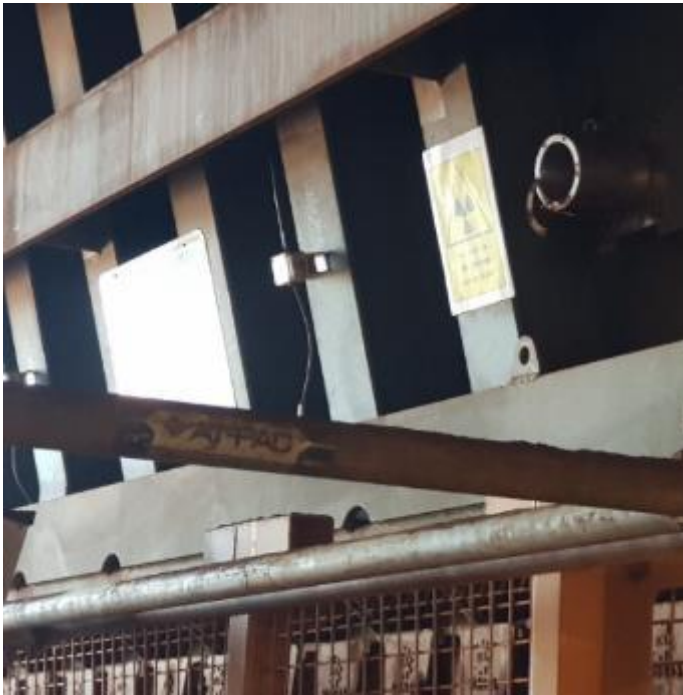
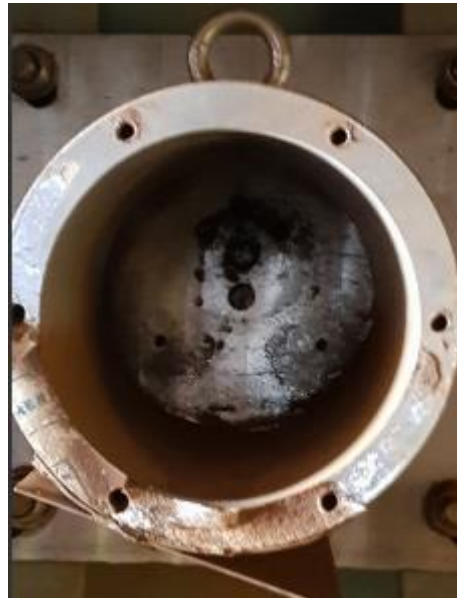
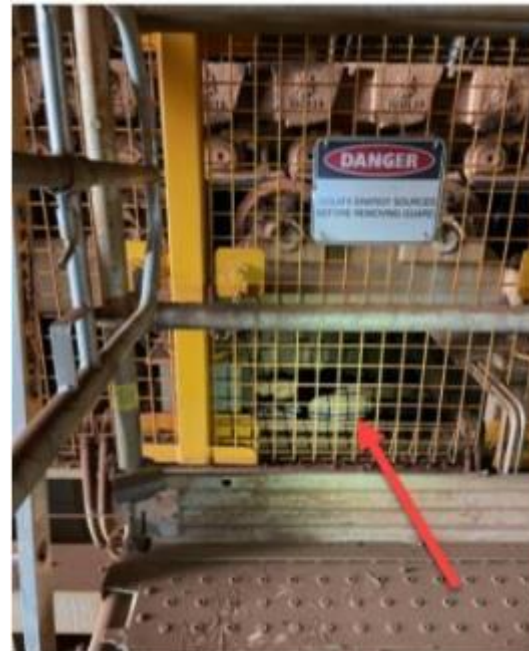
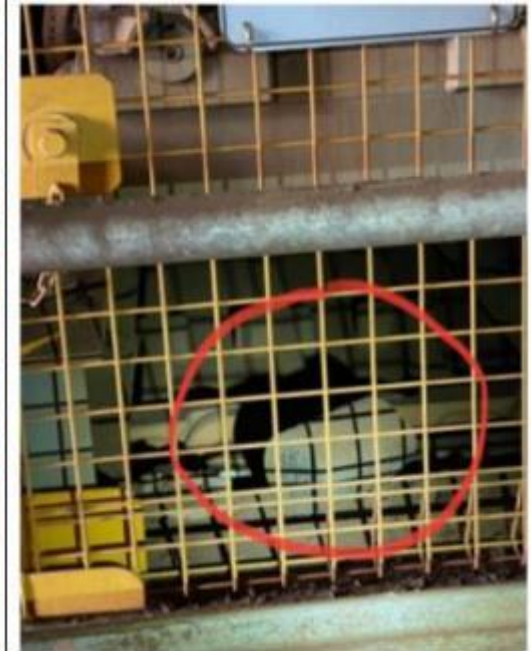
# First Incident

- The top plate had totally separated from the rest of the housing. Bolts were NOT sheared off and appeared to have just come undone
- Shield housing still contained the source capsule and was found approximately 2m below

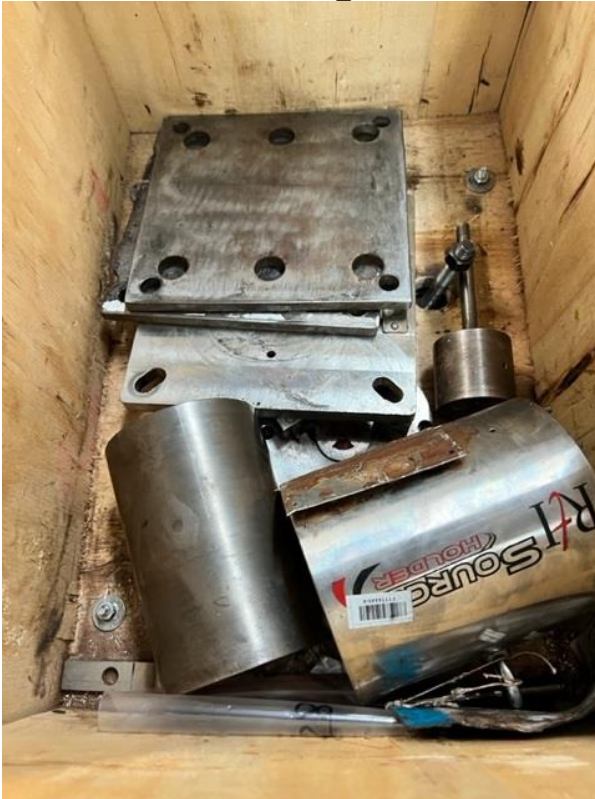
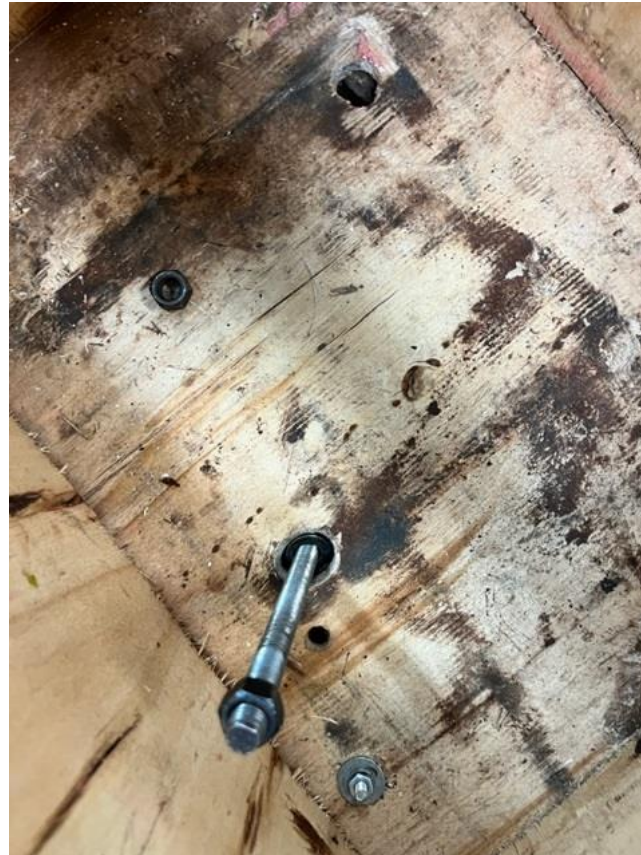
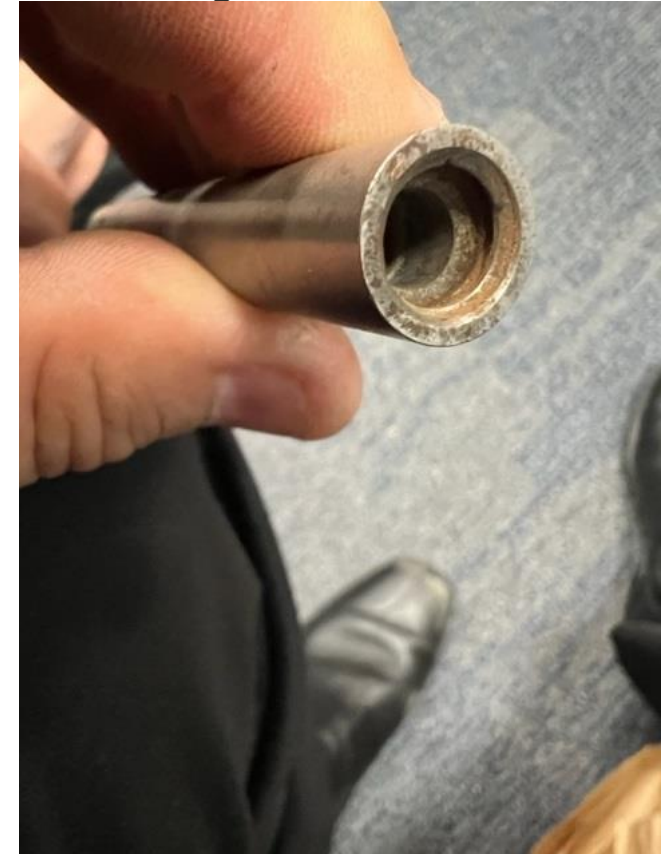
# Second Incident

- The gauge basically shook itself into its component pieces in the overpack
- One of the two mounting bolts vibrated loose, enlarged its hole and left this enlarged hole as an overpack penetration, This allowed movement of the gauge within the overpack
- Even the locking bolt at the end of the source rod holder was unscrewed and missing

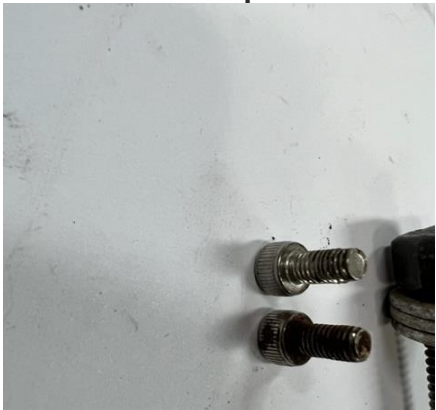
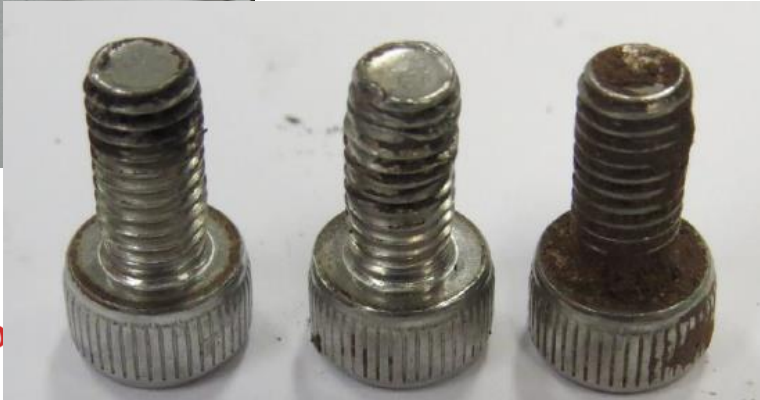
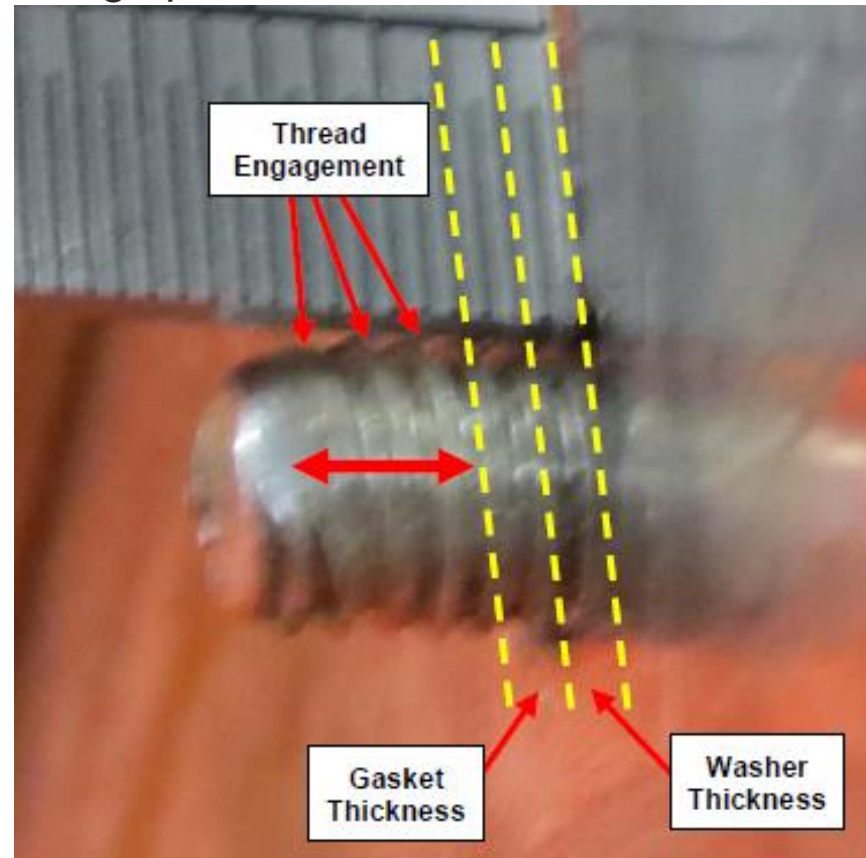
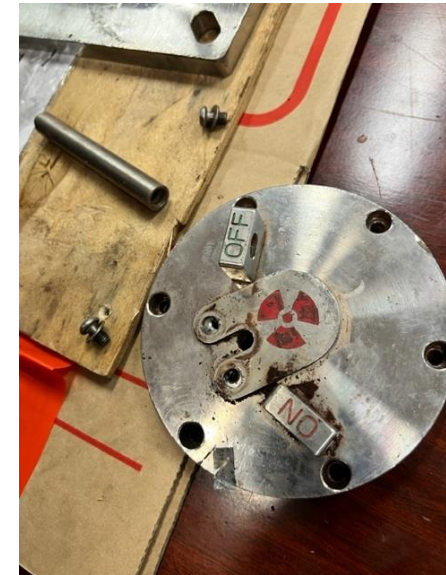
# Bolts and attachment

- Only one bolt remained attached for either the top or bottom plate and it was sheared off (a case of last man standing). Other bolts found show damaged threads
- The only design component for vibration was the use of spring washers (no nylon lock nut, Loctite, silicon filler, epoxy resin, etc.)
- Inconsistencies in size of bolt used (two manufacturing specification M5x20mm / M5x16mm and M5x10mm used in repair)

- Industrial packages particularly for gauges need to consider vibration and have good QA/QC. *NEW* designs are not necessarily better
- If a industrial package suffers a failure than the original IP certification may need to be re-examined

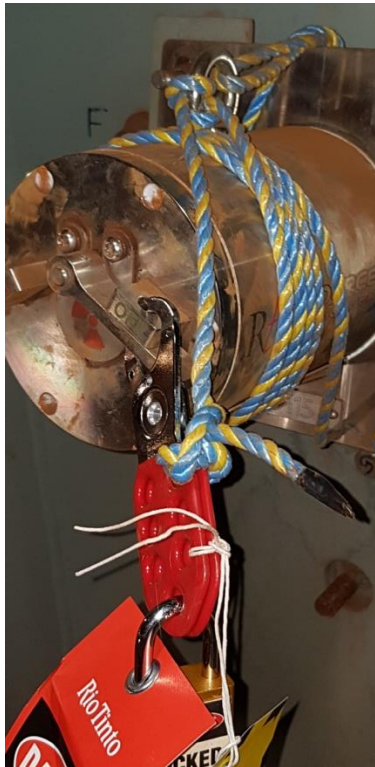
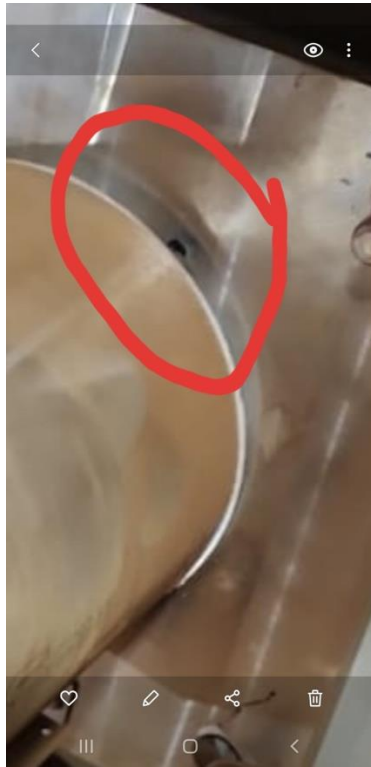
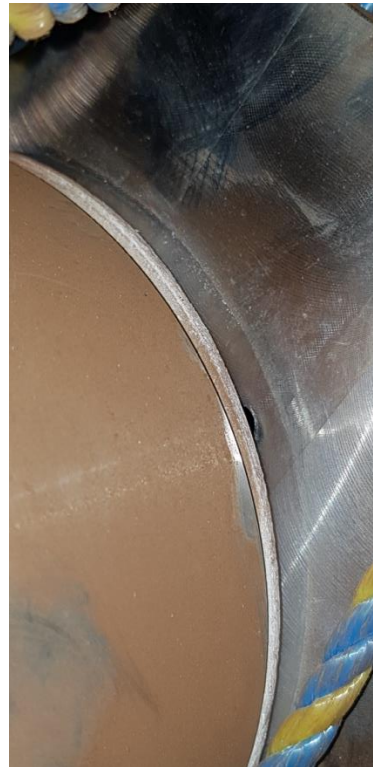
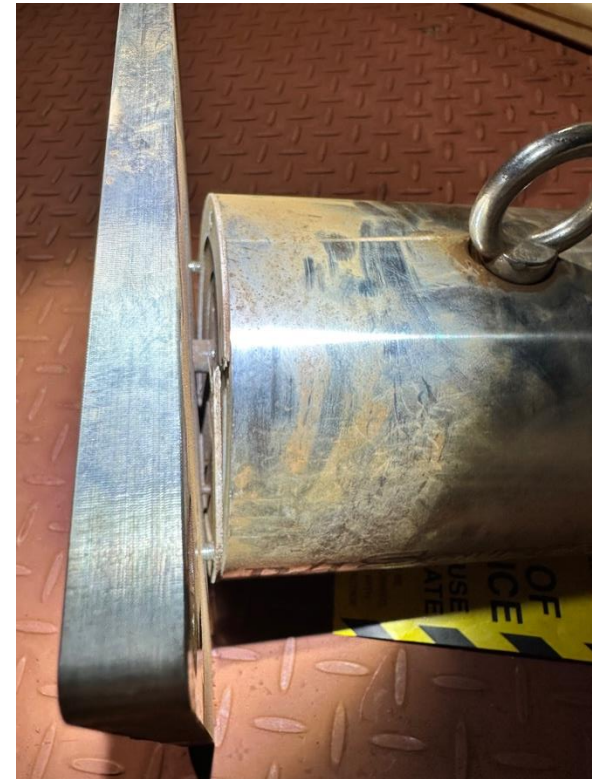
# Other gauges

- Rio Tinto had 5 gauges of the same design all purchased new (less than a year old) for the new plant and had only been in service less than six months
- All other gauges were inspected and taken out of service
- One gauge was two loose bolts from failing in a similar manner to the destroyed gauge

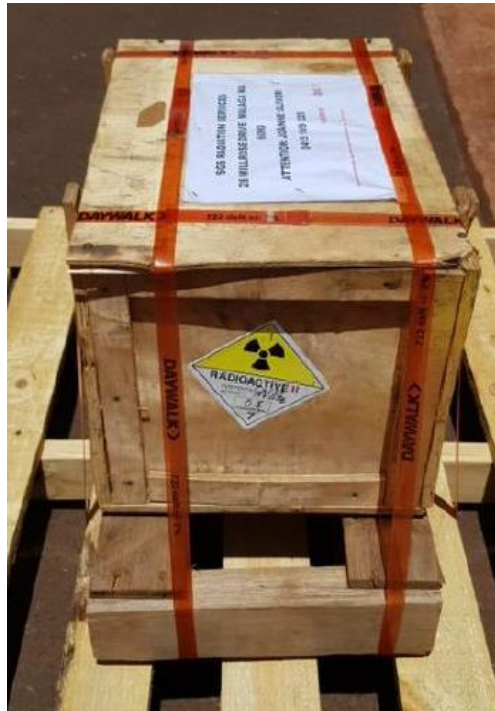
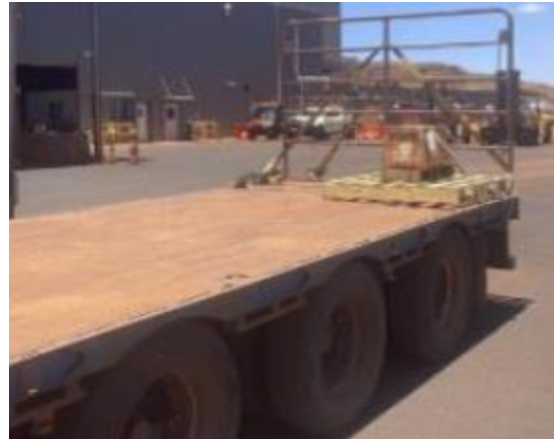
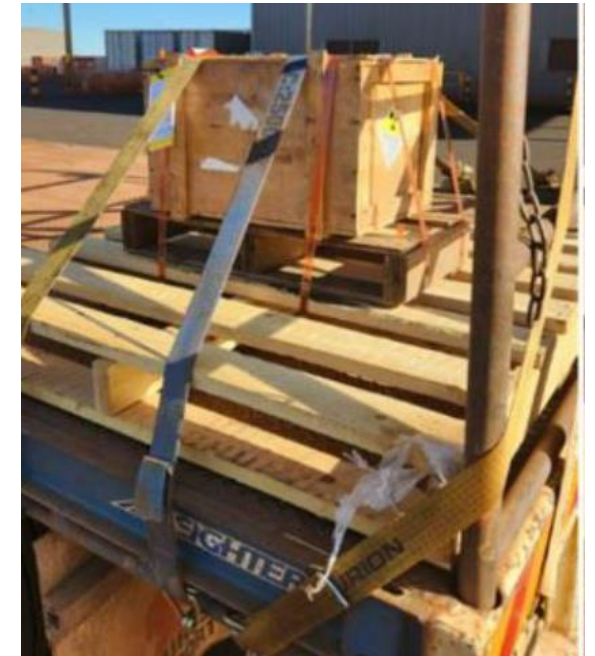
# Packaging

- Rio Tinto contracted a licensed and experienced firm to reassemble the gauge and package it for transport
- The gauge was attached to the base of the overpack using two bolts (in a similar way to how new gauges are sent from the manufacturer. Vibration failure of one bolt would lead to significant motion of gauge in overpack
- No additional packaging or precautions were taken despite the gauge being previously damaged with the exception of some additional steel plates at the base (for additional shielding due to shutter being broken
- The overpack was placed at the rear of the rear trailer of a B Double truck
