Industrial radiography: hand injury from exposure to X-ray beam

Description of the incident

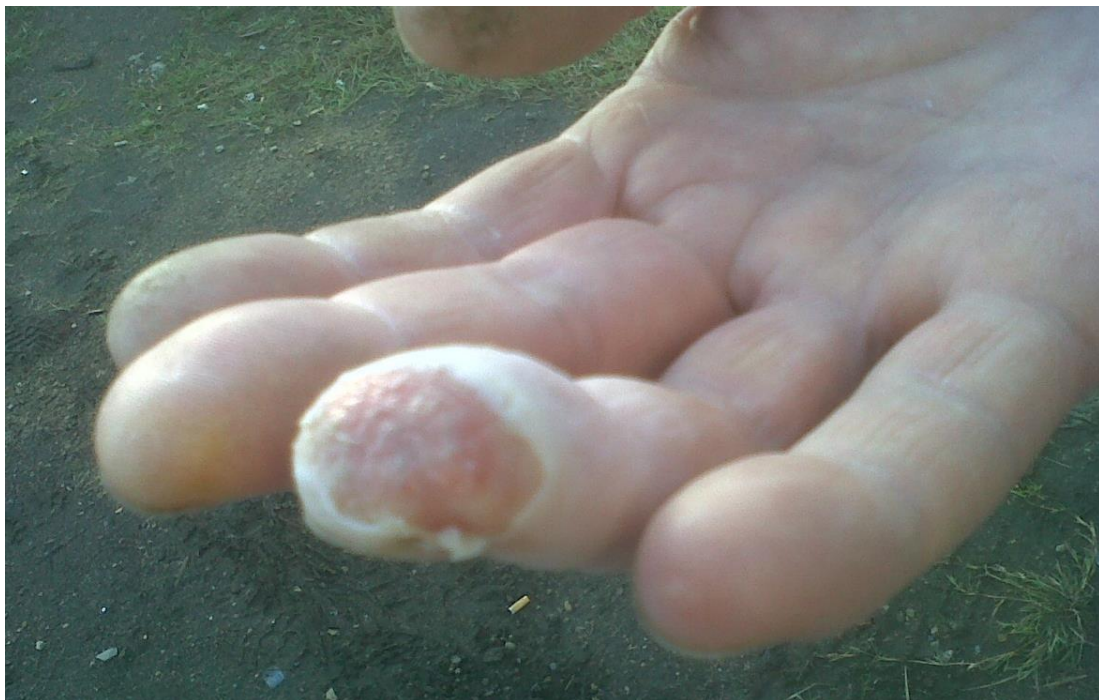
No immediate investigation was carried out: the incident was reported 3 weeks later when the radiographer informed the Company of radiation burns on the ends of his fingers (see Figure 1 below).

Figure 1 – Hand injury from overexposure to X-ray beam

It was estimated that the exposure to the radiographer's fingers was approximately 23 Sv (based on a 2 second exposure to the beam).

The radiographer suffered severe tissue damage to fingers on his right hand (see Figure 1). He did have surgery, but his fingers remain numb, with occasional tingling, although he has now been able to return to work.

- Industrial radiography uses high output sources. Even very short exposures to the main X-ray beam can produce radiation injuries. Safety and warning systems should never be disconnected or overridden unless other precautions can be put in place to maintain the same overall level of radiation safety.

- Industrial radiography safety systems should be regularly tested; however the testing methods should be subject to a proper risk assessment process, in consultation with a Radiation Protection Expert (RPE). Such an assessment would have highlighted the potential dangers of disconnecting the installed safety systems. In this case, it would have been relatively simple to arrange for alternative safety systems to prevent access to the enclosure during testing.

- Key-controlled X-ray control panels are an important safety feature. In this case, the key was left unattended in the control panel, even though the working instructions required it to be removed. In the subsequent investigation this was found to be a common practice.

- A separate independent safety system (in this case, an installed “gamma alarm” radiation detector) prevented the dose from being much higher. Personal electronic alarms/dosemeters provide a similar function, and should be considered for all industrial radiographers.

- There were no specific safe working procedures for testing the mobile safety systems, and there were no provisions for ensuring that this task was properly supervised.
