# **Final survey report for DR 1**

## **Clearance of building and land**

**Danish Decommissioning, Roskilde**  
**December 2005**

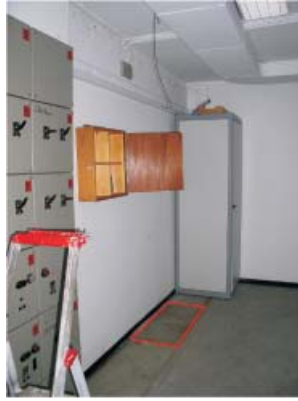
Some areas of the floor of the landing in the basement are classified as class 1 areas, as radioactive materials were stored here in cupboards. Also the small cupboards under the stairs and the steps of the staircase are classified as class 1 areas. The walls of the stairway are classified as class 2 areas not expected to be contaminated. Fig. 5 shows the area where the cupboard with the radioactive sources were located. Fig. 6 shows the small cupboards beneath the stairs.

*Figure 5. The landing of the stairway in the western basement. The area where the cupboard with the radioactive sources was situated is marked in red.*

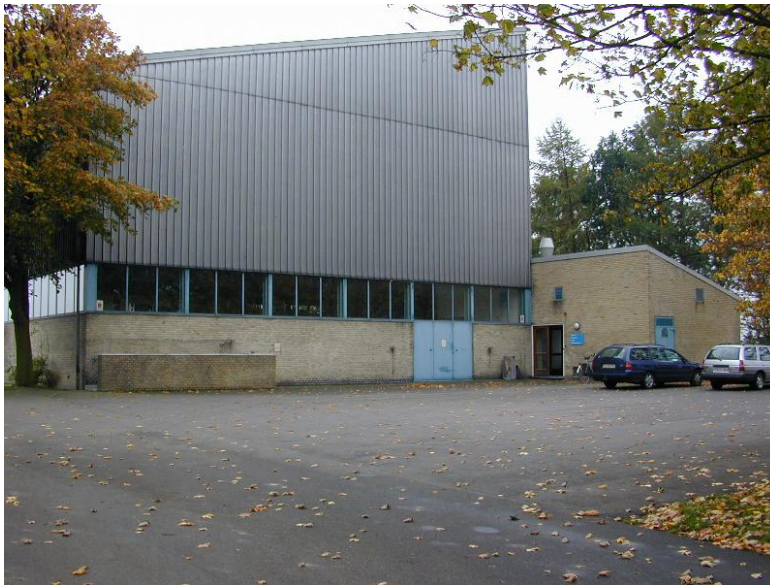
*Figure 9. The DR 1 building seen from north-east. The asphalt in front of the building is classified as a class 1 area, staircases leading to the basements are classified as class 2 areas, while the rest of the land areas in the vicinity of the reactor building are regarded as non-classified.*

The asphalt surface north of the building is classified as a class 1 area as all objects in the reactor building were transferred to containers outside the building via the gate in the reactor hall. The area was classified as a “blue contamination” area during the dismantling of the biological concrete shield, and, consequently, some contamination of the asphalt might have occurred.

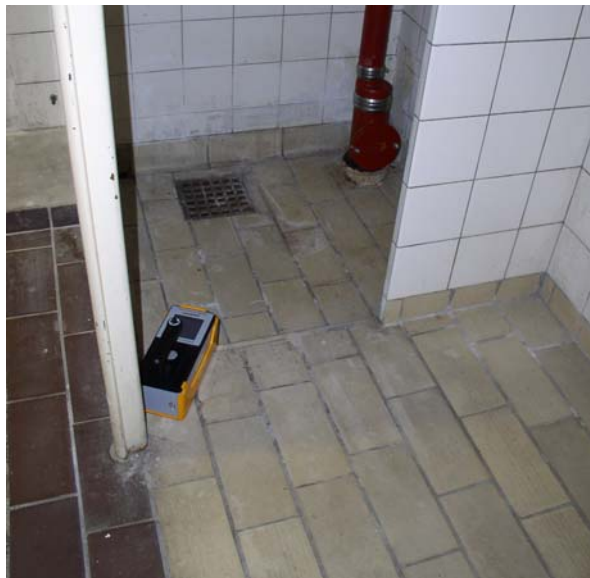
Although the room is classified as a class 2 area, the measurement coverage was 100%. The measurements at the floor in the locker room were performed with a Thermo Delta 5 ratemeter No. DD10 and a CoMo 170 No. DD5. The measurements at the floor in the shower cabin were performed with a CoMo 170 No. DD5. The measurements at the floor in the toilet was performed with a CoMo 170 No. DD5. These measurements indicated values somewhat higher than the normal background and, therefore, supplementary measurements were made with the portable NaI-gamma-spectrometer Exploranium GR-130 miniSPEC No. 3273. The measurements showed that the tiles had a significantly raised content in  $^{40}\text{K}$ , compared to other tiles in the room, which explained the elevated background. Fig. 10 shows one of the measurements with the Exploranium GR-130 detector.

*Figure 10. The measurement in the shower-cabin with the Exploranium NaI-detector.*

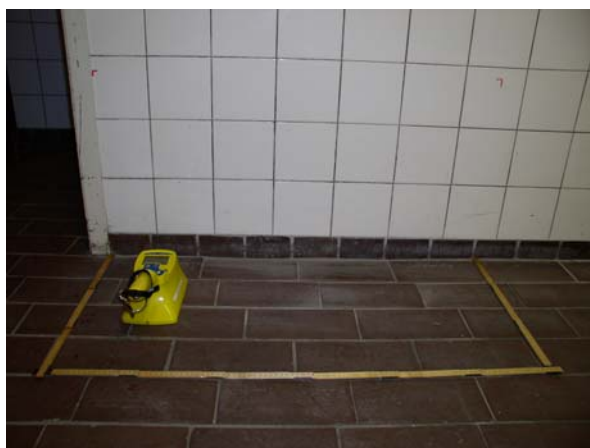
One corner of the floor showed even higher levels than the remaining part of the floor. Around this area one square meter was marked and measurements were made in the area. The measurement results showed that the clearance index,  $CI$ , was 0.11, and, consequently, the surface contamination was below the clearance levels. Fig. 11 shows the measurements in this area.

*Figure 11. The potentially contaminated area in the locker room. Measurements were made with a contamination monitor CoMo 170.*

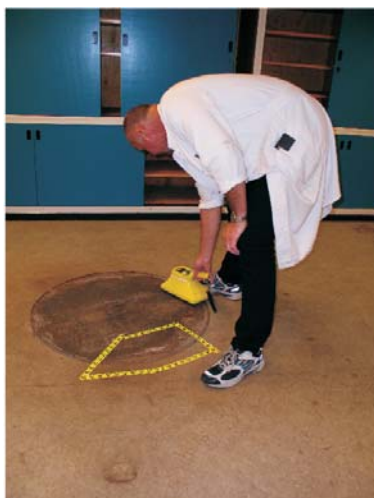
The floor was measured with a Thermo Delta 5 Ratemeter No. DD10. Along the walls the floor was measured with a CoMo 300 No. DD5. A contaminated area was found where the barrel with the shielding for the  $4\pi$  counter had been located. The contaminated spot was marked with tape as shown in Fig. 12.

*Figure 12. The contaminated area in the counting laboratory. It is clearly seen, where the barrel for the  $4\pi$ -counter was situated.*

The spot contamination was removed by vacuum cleaning. The vacuum cleaner bag was analysed by  $\gamma$ -spectrometry and the analysis showed small amounts of  $^{60}\text{Co}$ ,  $^{137}\text{Cs}$ , and  $^{152}\text{Eu}$ .

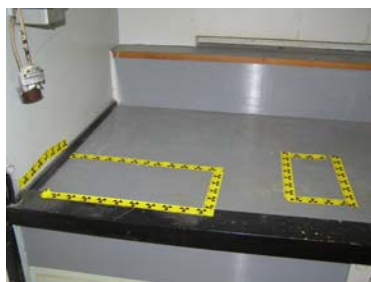
This room was measured to a nearly 100% coverage with contamination monitors. The instrument used was CoMo 170 No. DD5. Two contaminated spots were found on the table in the fume cupboard as indicated in Fig. 18.

Figure 18. The contaminated spots in the fume cupboard.

The table was decontaminated with a piece of cotton moistened with methylated spirit. The cotton was analysed by gamma spectrometry and traces of  $^{137}\text{Cs}$  was detected. After the decontamination the fume cupboard was checked for contamination with CoMo 170 No. DD5, and no contamination was found.

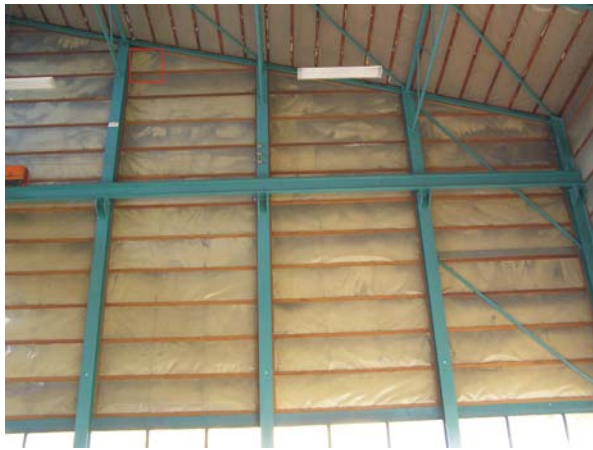
*Figure 25. The one square meter assumed to contain all the activity found on the eastern part of the northern wall.*

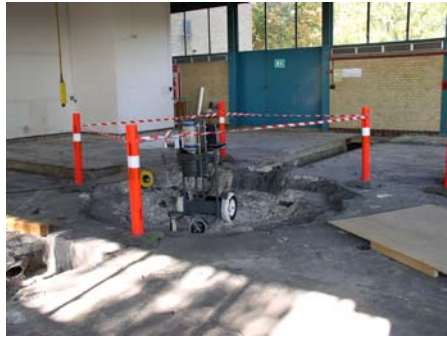
Figure 27. The measurement at the reactor foundation area.

Table 3 shows the result of the measurement in the area, where the reactor was situated. The radionuclides found were  $^{152}\text{Eu}$  and  $^{60}\text{Co}$ .

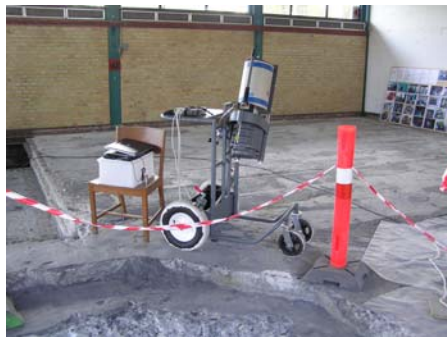
Figure 28. The measurement at the north-eastern part of the area where the biological shield was situated.

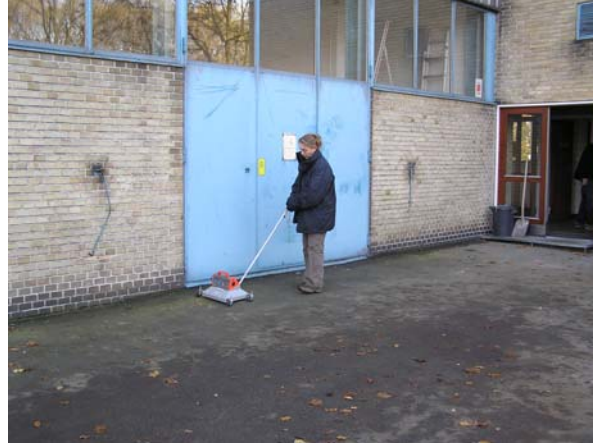
The asphalt to the north of the front of the reactor building was measured to a 100% coverage for contamination with contamination monitors Thermo Delta 5 No.6578, Thermo Delta 5 No. DD10, and CoMo 170 No. DD5. No contamination was found.

*Figure 29. The measurement with a contamination monitor on the area north of the building.*

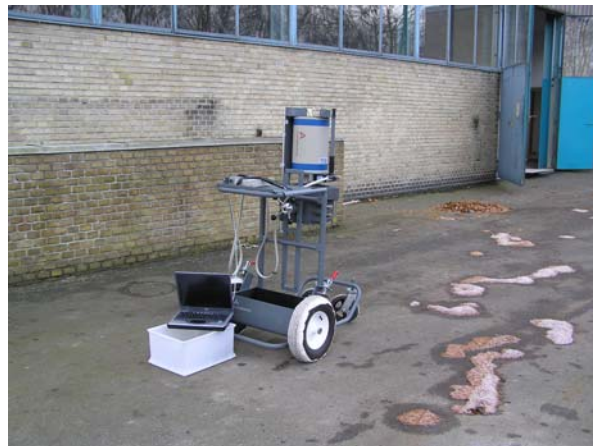
One measurement was made with a Ge-detector on the asphalt area. A background spectrum was measured at a Risø area with a similar type and age of asphalt. No radionuclides resulting from the operation and decommissioning of DR 1 was found in the measurement on the asphalt in front of the DR 1 building.

*Figure 30. Gamma-spectrometric measurement at the asphalt area north of the building.*
