Final survey report for DR 1 Clearance of building and land

Danish Decommissioning, Roskilde December 2005

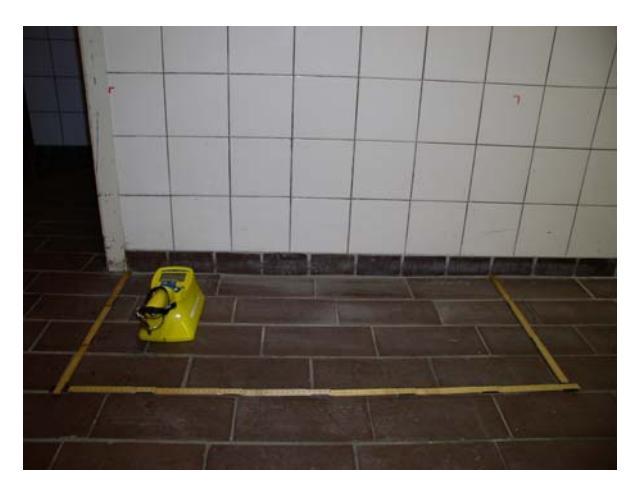
One corner of the floor showed even higher levels than the remaining part of the floor. Around this area one square meter was marked and measurements were made in the area. The measurement results showed that the clearance index, CI, was 0.11, and, consequently, the surface contamination was below the clearance levels. Fig. 11 shows the measurements in this area.

Figure 11. The potentially contaminated area in the locker room. Measurements were made with a contamination monitor CoMo 170.

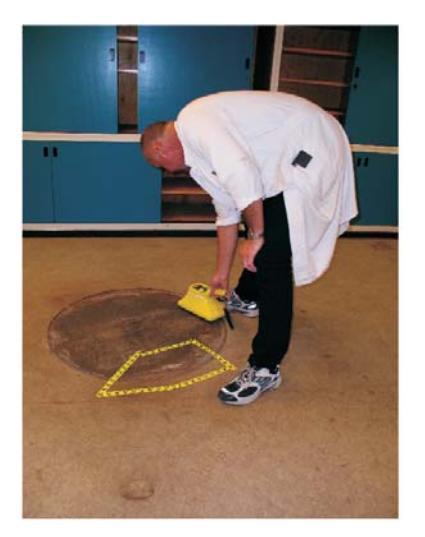
The floor was measured with a Thermo Delta 5 Ratemeter No. DD10. Along the walls the floor was measured with a CoMo 300 No. DD5. A contaminated area was found where the barrel with the shielding for the 4π counter had been located. The contaminated spot was marked with tape as shown in Fig. 12.

Figure 12. The contaminated area in the counting laboratory. It is clearly seen, where the barrel for the 4π -counter was situated.

The spot contamination was removed by vacuum cleaning. The vacuum cleaner bag was analysed by γ -spectrometry and the analysis showed small amounts of 60 Co, 137 Cs, and 152 Eu.

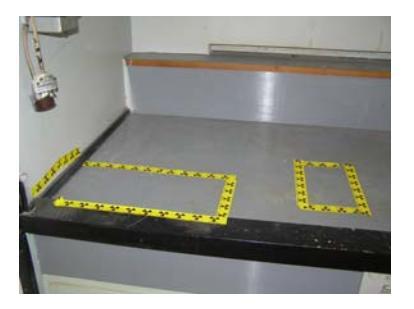
This room was measured to a nearly 100% coverage with contamination monitors. The instrument used was CoMo 170 No. DD5. Two contaminated spots were found on the table in the fume cupboard as indicated in Fig. 18.

Figure 18. The contaminated spots in the fume cupboard.

The table was decontaminated with a piece of cotton moistened with methylated spirit. The cotton was analysed by gamma spectrometry and traces of 137 Cs was detected. After the decontamination the fume cupboard was checked for contamination with CoMo 170 No. DD5, and no contamination was found.

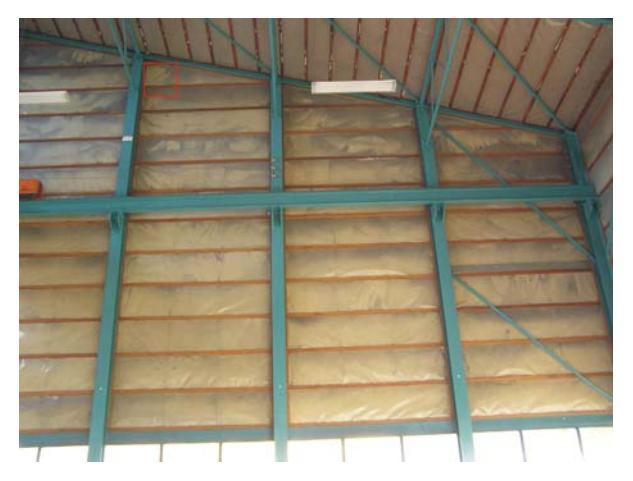
Fig. 25 shows the square meter assumed to contain all the activity measured on the eastern part of the northern wall.

Figure 25. The one square meter assumed to contain all the activity found on the eastern part of the northern wall.

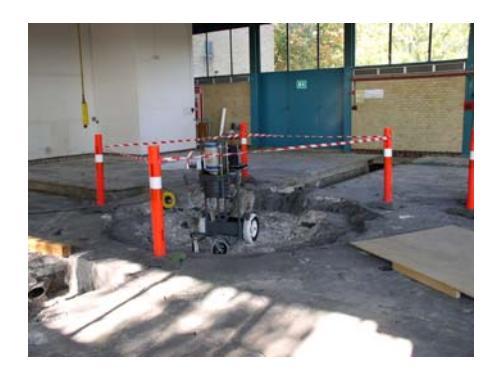
The second, third and fourth measurement covered the edge of the "crater", *i.e.* the area where the biological shield were situated. One measurement was made where the biological shield had the lowest activity, and one measurement, where the biological shield had the highest activity. The last measurement was made on one of the remaining edges to confirm the other measurements. Again, the detector covered at least one square meter and it was conservatively assumed, that all the activity was concentrated below one square meter.

Figure 27. The measurement at the reactor foundation area.

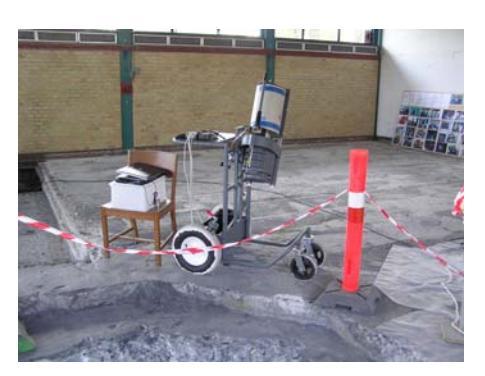
Figure 28. The measurement at the north-eastern part of the area where the biological shield was situated.

Table 3 shows the result of the measurement in the area, where the reactor was situated. The radionuclides found were $^{152}\rm{Eu}$ and $^{60}\rm{Co}.$

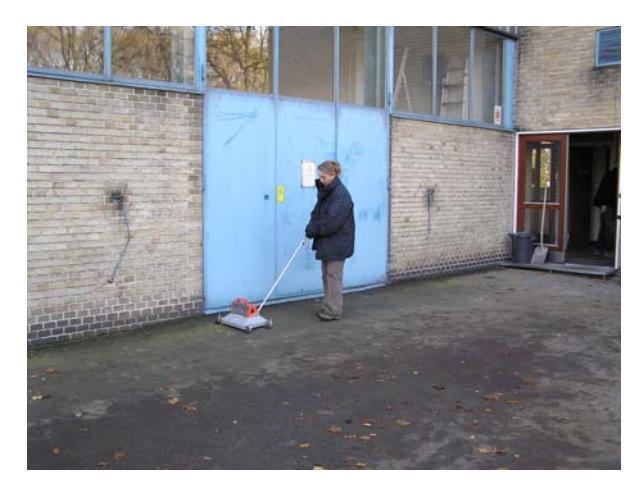
The asphalt to the north of the front of the reactor building was measured to a 100% coverage for contamination with contamination monitors Thermo Delta 5 No.6578, Thermo Delta 5 No. DD10, and CoMo 170 No. DD5. No contamination was found.

Figure 29. The measurement with a contamination monitor on the area north of the building.
