## STUDY CASE N° 19: RADIONUCLIDE GAUGES IN ROUGH INDUSTRIAL ENVIRONMENTS

*European ALARA Newsletter: Issue 18*

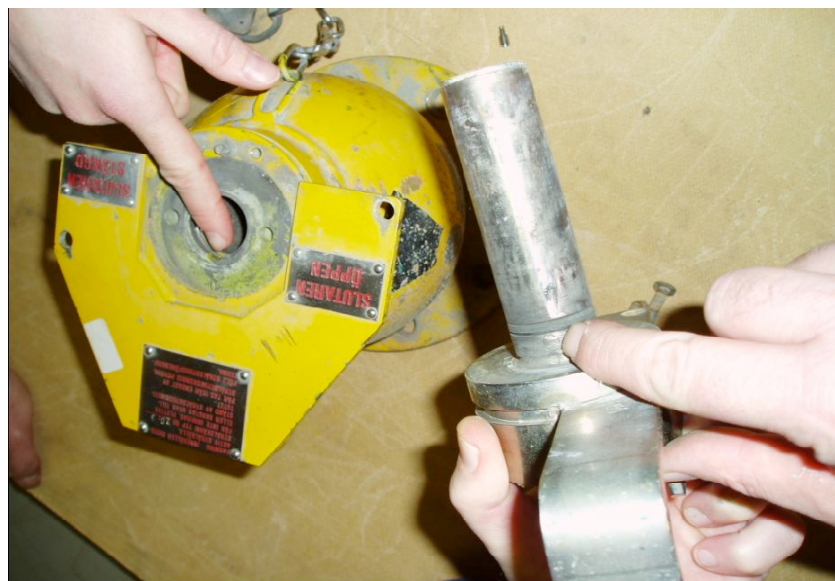
The particular gauge model (see Figure 1), which is commonly used with no problem, was found to fail in dusty and vibratory environments after about 10 years of use.

**Figure 1: The pin (~ 5mm) securing the locking mechanism to a slit in the source housing was grinded off.**

When the pin securing the locking mechanism is grinded off, only the sealing will hold the shutter mechanism in place. The thin metal wire of the sealing is not meant for holding the gauge together, and is easily snatched off (e.g. by vibration).

These serious incidents happened to a well-known gauge model. The gauge is of a so-called “Scandinavian” or “Swedish” design, and the use of this model outside Scandinavia is unknown to us. The manufacturer is now making a model specially made for vibratory environments.

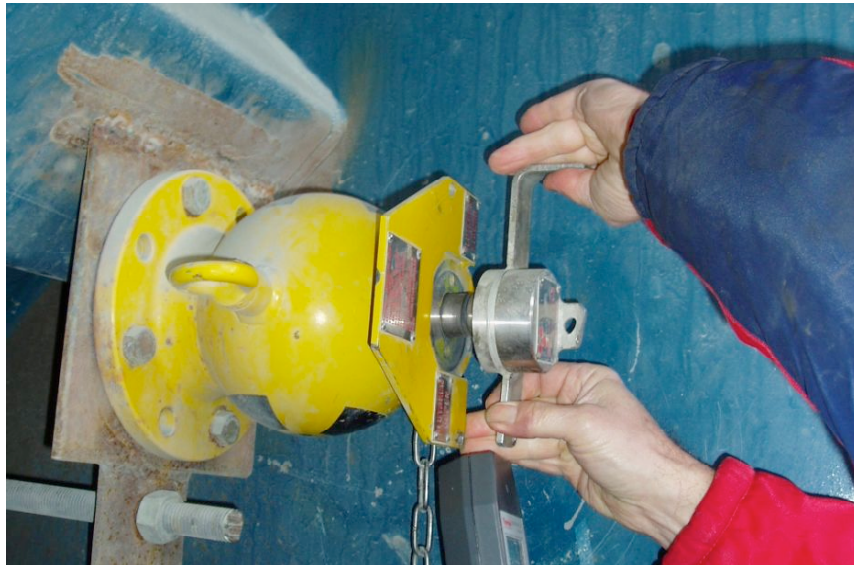
**Figure 2: For security reasons the gauge is not usually padlocked in open position, and with the pin grinded off the source holder is easily removed from the shielding.**

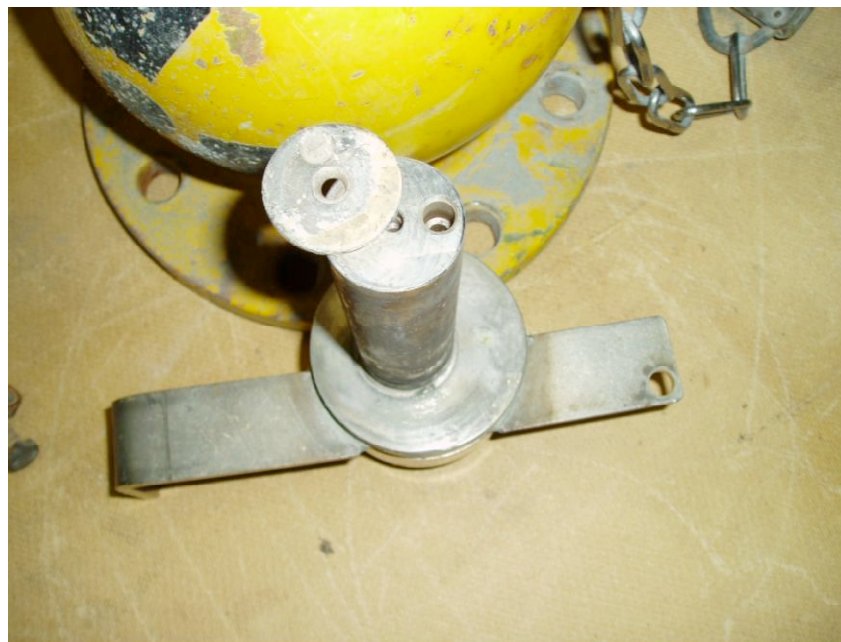
**Figure 3: The gauge with the missing source also missed the screw keeping the spring-loaded plate in place.**

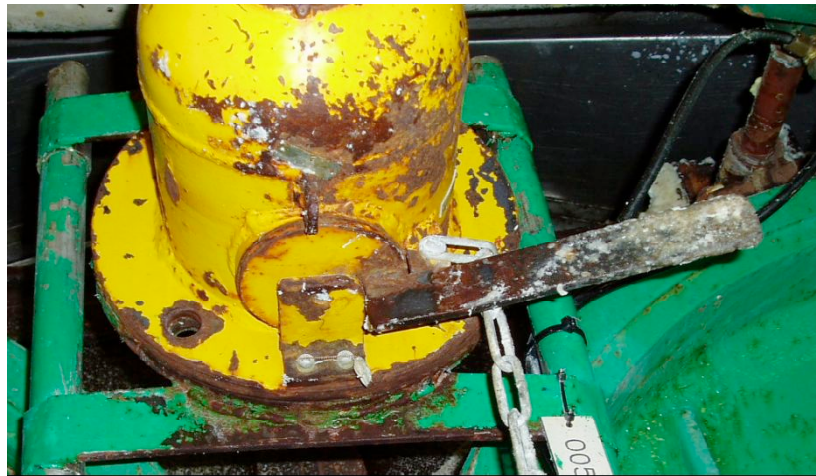
In figure 4 an extended handle has been welded on the shutter mechanism in such a way that extra force might be used to open and shut the rusty gauge (for example with the use of a hammer). There are examples where this has led to shutter damage and the gauge has no longer been able to be put in shut position.

**Figure 4: Rusty radionuclide gauge with extended handle**

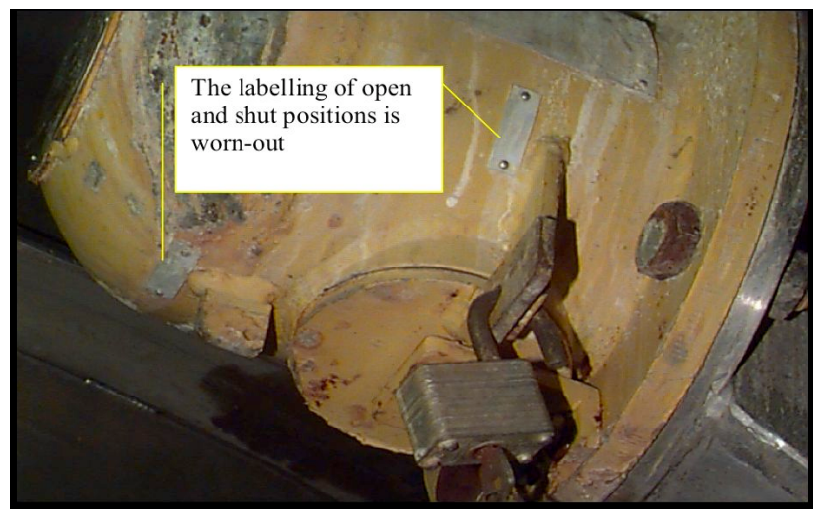
In some industrial environments chemical agents might wipe out the labels and markings, or they are covered with production waste.

**Figure 5: The labelling of open and shut position is worn-out.**

The lesson learned from inspections is first of all that the undertakings should prepare instructions and work procedures which ensure proper cleaning and maintenance of the radionuclide gauges.

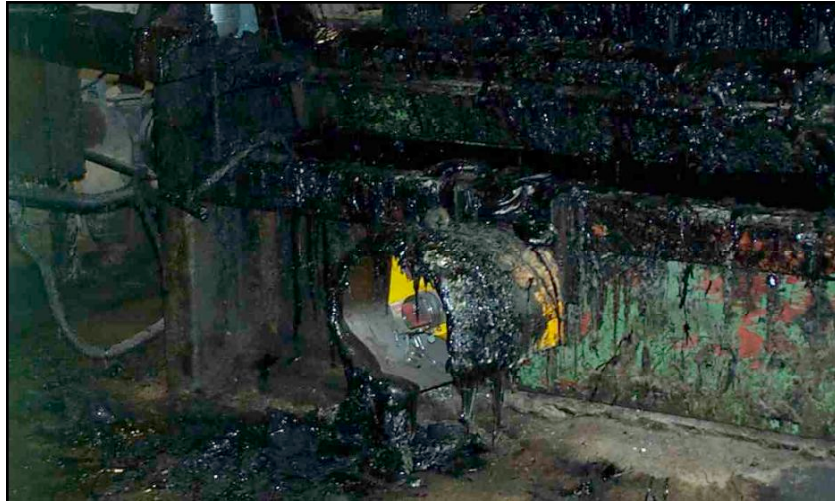
**Figure 6: Challenging environment, but in this case the gauge is protected by a mudguard and a trefoil warning sign was placed to the right of the picture.**

Production waste covering the warning labels is also a safety threat, and procedures for cleaning labels regularly are important to have in place.
