# **Operational aspects of decommissioning of installations containing mineral wool**

**E.I.M. Meijne, G. Gul and M.L.J. Kok, NRG, Radiation & Environment, The Netherlands**

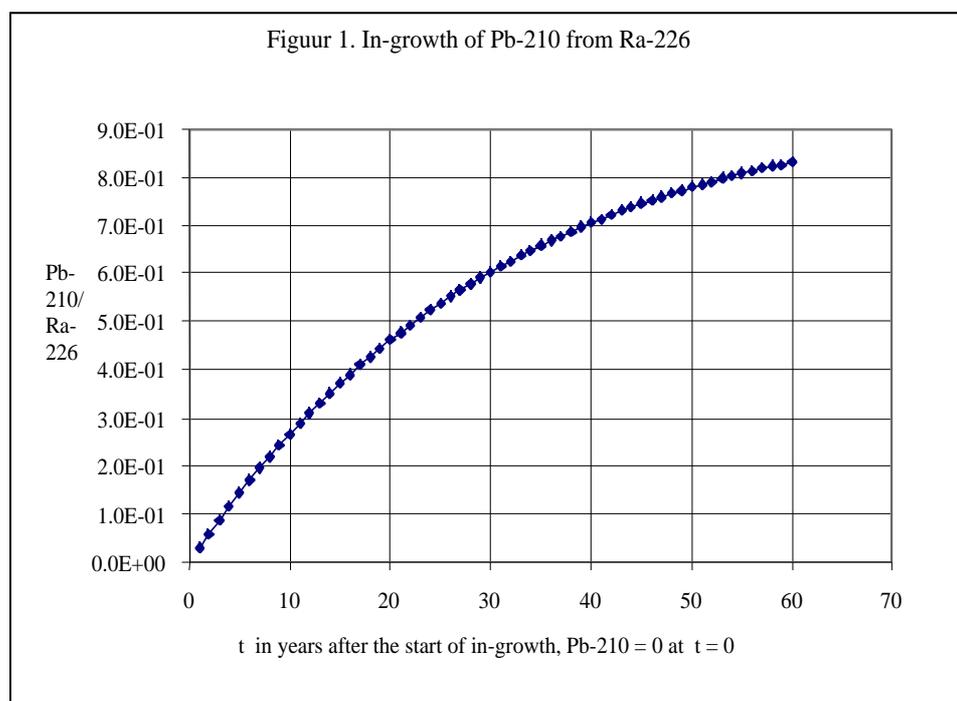
Gammaspectrometric analyses show that slag wool is characterised by higher concentrations Th-232 than U-238. The average ratio Th-232/U-238 is about 3 and varies from 4.2 to 1.8 (see Table 1). Ra-226 and its short-lived daughters are in equilibrium with U-238. Pb-210 (and consequently also Po-210) are slightly depleted. The ratio Pb-210/ Ra-226 is about 0.8. From this ratio an average age for slag wool of approximately 50 years can be calculated if it is assumed that all Pb-210 was volatilised at the time of slag or slag wool production. This coincides with the production period of tin slag.

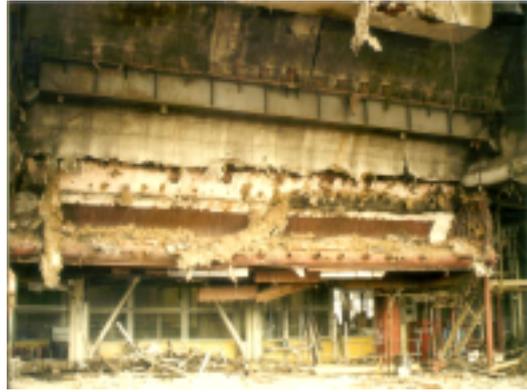
Picture 2 : slagwool visible after uncontrolled dismantling

Because the presence of radioactive material had not been considered when decommissioning was started the demolishing of the slag wool containing kettle 1 and 2 had been carried out in an uncontrolled manner. As a consequence slag wool was spread over a large area and large parts of the installation containing slag wool were opened (picture 2). Before the dismantling of the power plant could be continued, now under radiological controlled conditions, the present situation had to be rehabilitated by collecting the slag wool spread onto floors and covering the slag wool containing parts of the installation that were only partly dismantled.

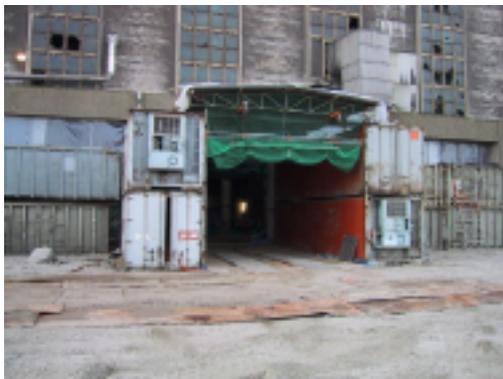
Picture 3 : Example of remedial actions taken to prevent spreading of slag wool to the environment.

A work plan specifying how the work activities would be carried out had to be submitted to the Inspectorate. The main aim of the work plan was prevention of spreading of slag wool in the building and to the environment, prevention of exposure of workers and removal of the slag wool. The work activities were performed in a supervised area by qualified asbestos removers under supervision of a radiation protection officer. Personal protection equipment included Tyvec coveralls, gloves, safety boots and breathing protection (Power packs with P-3 filter, picture 5). A vacuum cleaner type HDZ 750 with absolute filter was used to remove smaller slag wool parts and a shower unit was installed at the end of the supervised area. Large openings in the building were closed by means of containers (picture 3). Spreading of slag wool in the building was prevented by constructing compartments by means of scaffoldings and plastic foil (picture 4). All slag wool was put in double plastic bags and stored in containers. Building rubble and soil containing trace amounts of slag wool were collected in big bags and sampled. On the basis of gammaspectrometric analyses these could be released as non-radioactive waste. It took a few months to collect all slag wool spread in the installation by the uncontrolled demolishing of the building.

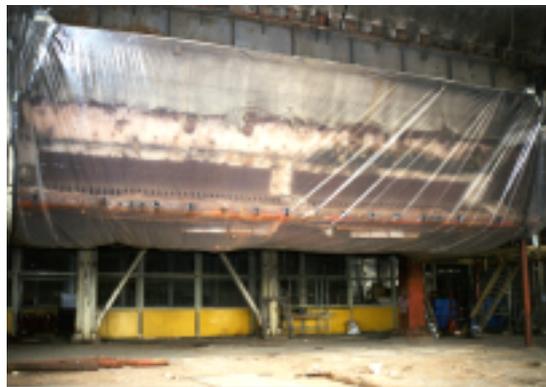
Picture 4 : Example of remedial actions taken to prevent spreading of slag wool in the building.

The decommissioning of the power plant could be continued in March 2000. With a surface contamination monitor measurements were performed in the entire installation. All parts containing slag wool were marked. A plastic containment was built around all remaining slag wool containing parts of the installation to allow for controlled decommissioning and prevent the spreading of radioactive material.

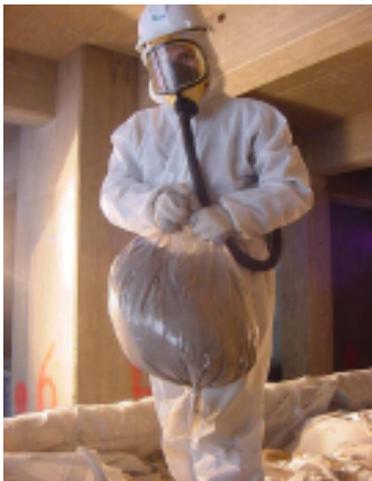
Picture 5 : Collection of slag wool

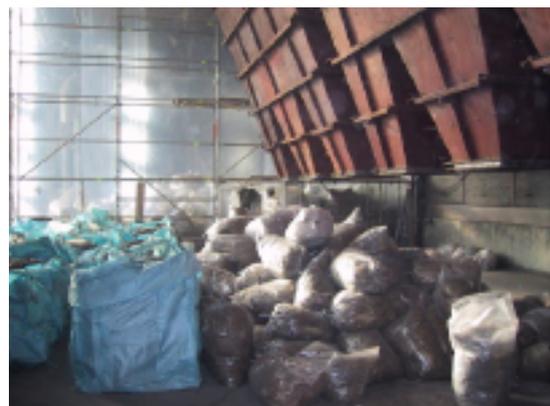
Picture 6 : Slag wool remaining after Decommissioning.

After dismantling of the power plant 36 tonnes of slag wool remained stored in hundreds of plastic bags (picture 6). Because the activity concentration was above the concentration level for radioactive material requiring authorisation, the material has to be stored at COVRA if considered as radioactive waste. Solid waste has to be packed in 100 litre metal COVRA drums. The maximum weight of the content in a drum is 60 kilograms. To reduce the volume of the waste, the slag wool was compressed with a press (picture 7) and stored in plastic bags (sausages) each weighing approximately 30 kilograms (picture 8). Compression reduced the volume and thus the size of the storage facility and facilitated the handling of the waste. Moreover in case no other option would become available two plastic bags could be placed in one COVRA drum to allow optimal filling of the drums to reduce the costs of waste disposal as much as possible. Even when optimal filling of COVRA drum could be obtained the costs of transfer of the slag wool into COVRA drum and transfer to COVRA are estimated at about 650,000 EURO, more than 100 times the cost of disposal to a normal landfill.

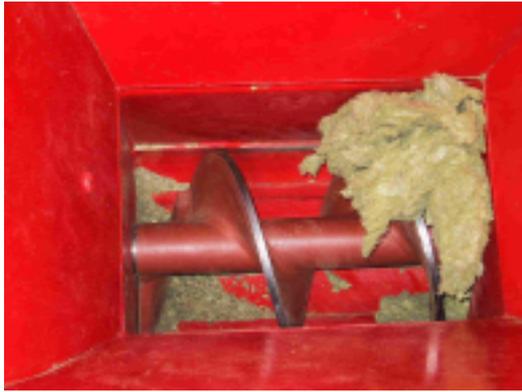
Picture 7 : Compression of slag wool

In collaboration with the Ministry of VROM options for re-use of the slag wool have been investigated. A possible option that will be investigated is the use of slag wool as replacement for gravel at a phosphorus production plant. To be able to feed the slag wool into the ovens of Thermphos the slag wool had to be repacked in 15 litre drums. During repackaging of the slag wool in 15 litre drums it appeared that compressing of the slag wool had led to pulverisation of the material (figure 9) making it extremely difficult to handle without the generation of a lot of dust (figure 10). Storage of slag wool in big bags is therefore preferred option above compression until a final re-use option / disposal options for slag wool has been agreed upon.

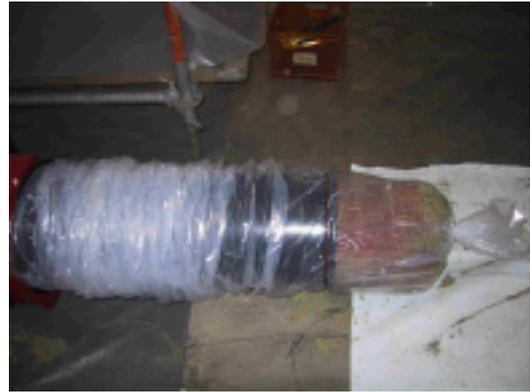
Picture 8 : Compressed slag wool

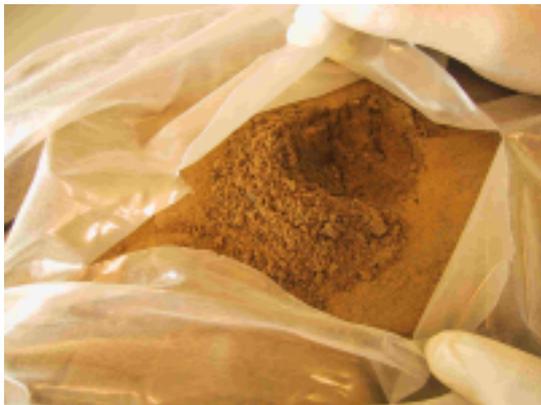
Picture 9 : Slag wool after compression

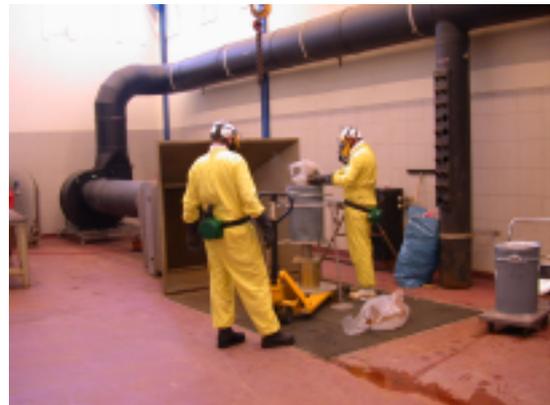
Picture 10 : Filling of 15 litre test drums
