Final survey report for DR 1 Clearance of building and land

Danish Decommissioning, Roskilde December 2005

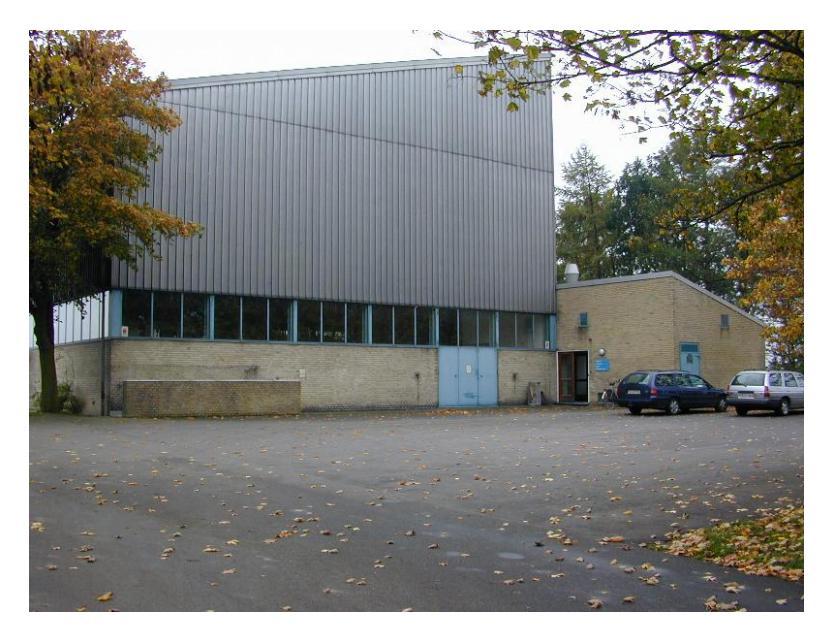
Figure 9. The DR 1 building seen from north-east. The asphalt in front of the building is classified as a class 1 area, staircases leading to the basements are classified as class 2 areas, while the rest of the land areas in the vicinity of the reactor building are regarded as non-classified.

The asphalt surface north of the building is classified as a class 1 area as all objects in the reactor building were transferred to containers outside the building via the gate in the reactor hall. The area was classified as a "blue contamination" area during the dismantling of the biological concrete shield, and, consequently, some contamination of the asphalt might have occurred.

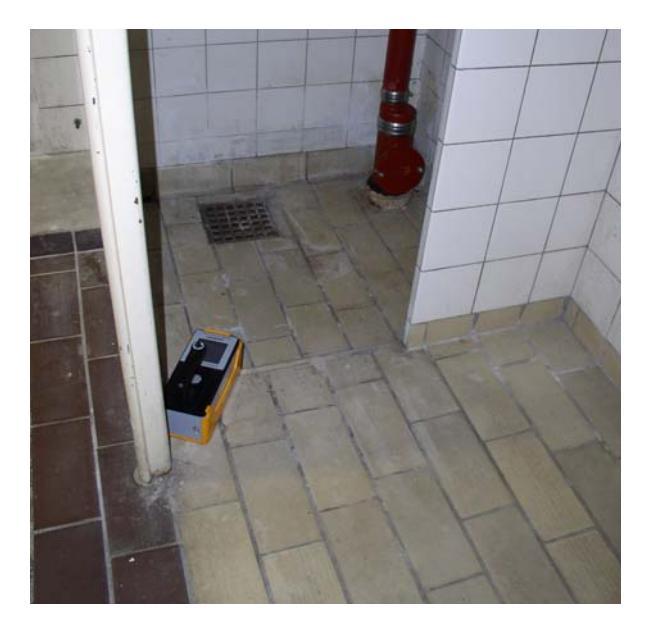
Although the room is classified as a class 2 area, the measurement coverage was 100%. The measurements at the floor in the locker room were performed with a Thermo Delta 5 ratemeter No. DD10 and a CoMo 170 No. DD5. The measurements at the floor in the shower cabin were performed with a CoMo 170 No. DD5. The measurements at the floor in the toilet was performed with a CoMo 170 No. DD5. These measurements indicated values somewhat higher than the normal background and, therefore, supplementary measurements were made with the portable NaI-gamma-spectrometer Exploranium GR-130 miniSPEC No. 3273. The measurements showed that the tiles had a significantly raised content in ⁴⁰K, compared to other tiles in the room, which explained the elevated background. Fig. 10 shows one of the measurements with the Exploranium GR-130 detector.

Figure 10. The measurement in the shower-cabin with the Exploranium NaIdetector.

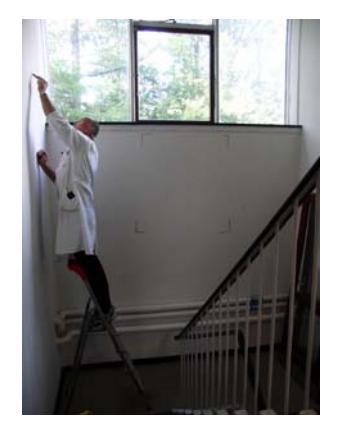
The stairs were measured with contamination monitors CoMo 170 No. DD5 and CoMo 300 No. 6694. The walls along the stairs were measured to a 100% coverage to a height of one meter. On the remaining part of the walls, three surfaces, each of one square meter, were randomly chosen and measured with a contamination monitor CoMo 300 No. 6694. No contamination was found. Fig. 14 shows the marking of the wall.

Figure 14. A surface of one square meter is marked on the wall of the stairway.

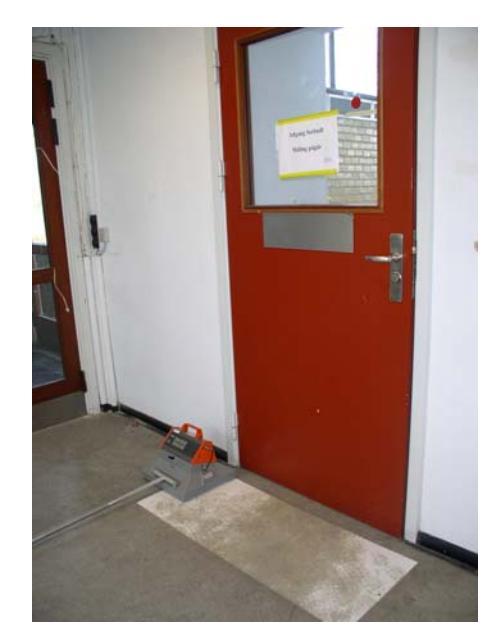
The landing at the first floor was measured to a nearly 100 % coverage. The floor was measured with a contamination monitor Thermo Delta 5 No. DD10, and the walls, doors, ceiling, and ventilation pipe were measured with a contamination monitor CoMo 170 No. DD5. No contamination was found. The wall behind the ventilation pipe and the ceiling over the ventilation pipe were not measured. Figure 15 shows the measurement on the floor with the contamination monitor Thermo Delta 5.

Figure 15. The measurement of the floor at the upper landing of the stairway.

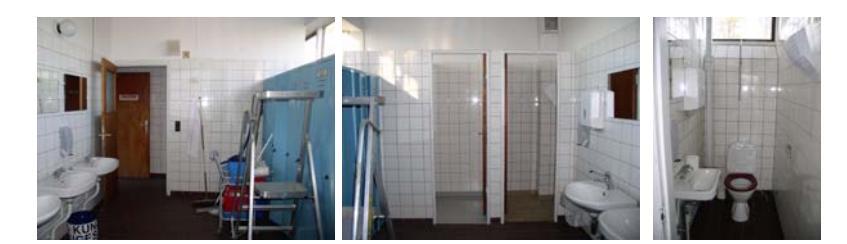
The walls, the ceiling, the floor, and all objects in the locker room were measured for contamination with contamination monitors CoMo 170 No. DD5 and DD21. No contamination was found.

In the toilet, the floor, the door, the walls, the toilet and other objects were measured for contamination with a CoMo 170 No. DD5. No contamination was found.

Figure 16. The locker room and the toilet at the first floor.

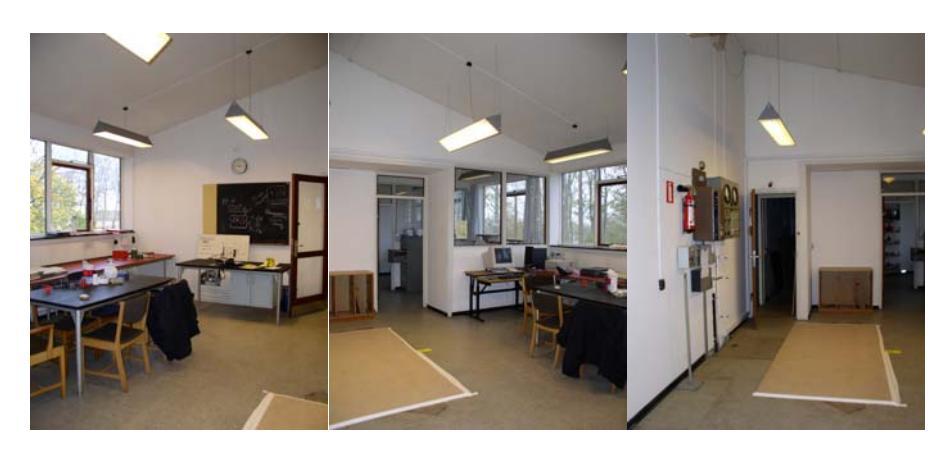
Although the control room is regarded as a class 2 area it was measured to a nearly 100% coverage. The floor was measured with a contamination monitor Thermo Delta 5 No. DD10. The walls, the ceiling, the doors, the window sills, the different objects and the furniture and fixtures were measured with a CoMo 170 No. DD5. No contamination was found.

Figure 17. The control room seen from different angles.

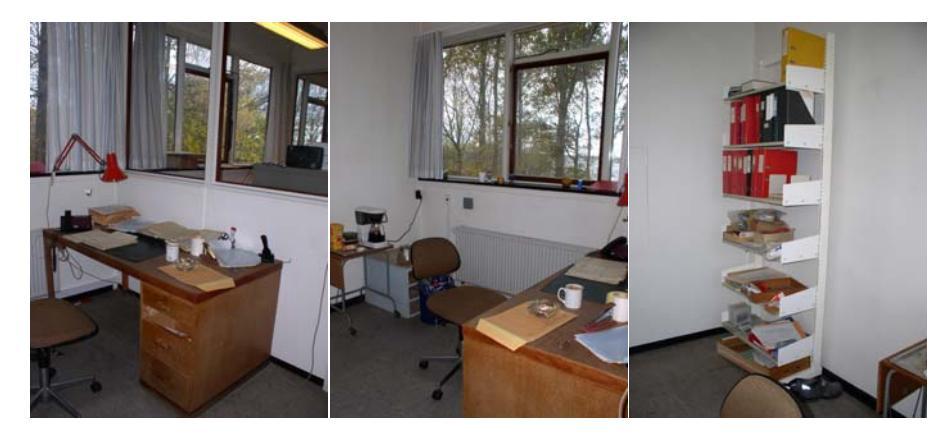
Figure 19. Office No. 1.

Although classified as a class 2 area, the room was checked for contamination to a nearly 100% coverage. The floor was measured to a 100% coverage with a Thermo Delta 5 No. DD10 contamination monitor. The walls, window sills, ceiling, objects, papers and furniture were measured with a contamination monitor CoMo 170 No. DD5. No contamination was found. Fig. 19 shows the office.

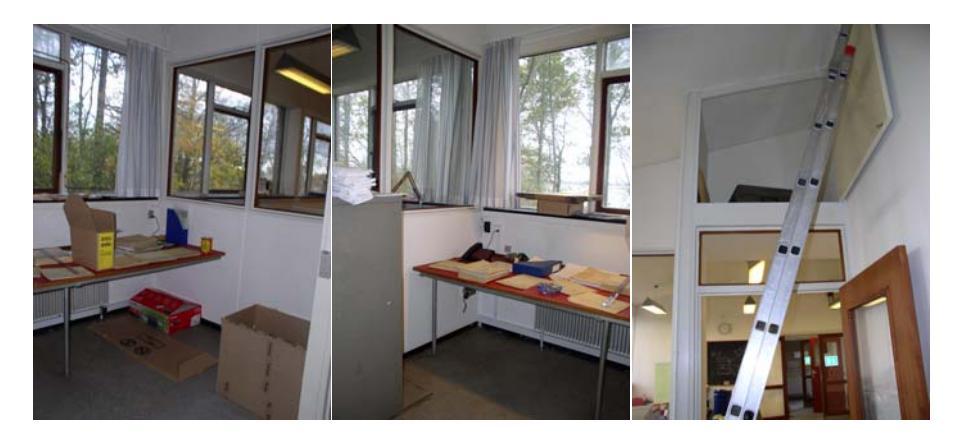
Figure 20. Office No. 2.

Although classified as a class 2 area, the room was checked for contamination to a nearly 100 % coverage. The floor was measured with a Thermo Delta 5 No. DD10 contamination monitor. The walls, window sills, ceiling, objects, papers and furniture were measured with a contamination monitor CoMo 170 No. DD5. No contamination was found. Fig. 20 shows the office.

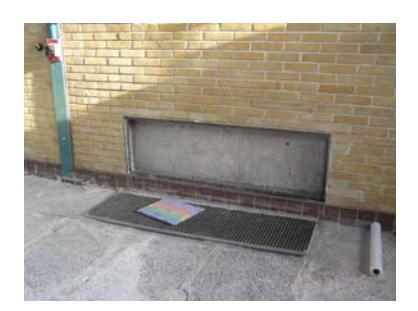
The ducts for the heating system are not accessible. It was assumed that if any contamination was to be found in the ducts, it could be detected behind the ventilation grills of the outlet from the hall. The wall behind the grills were measured with contamination monitor CoMo 170 No. DD5. No contamination was detected. Some dust behind the ventilation grills was scraped off the wall and analysed by gamma-spectrometry in the laboratory. The sample showed small amounts of ¹³⁷Cs and ⁶⁰Co. Assuming conservatively that there was a dust covering of half a kilogram at each square meter, the surface contamination of ¹³⁷Cs would be less than 1500 Bq/m² and less than 200 Bq/m² for ⁶⁰Co. It was therefore concluded, that the contamination of the ducts would be far below the clearance levels.

Figure 21. The heating air outlet from the reactor hall. The ventilation grills have been removed for measurements behind the grill and in the ducts.

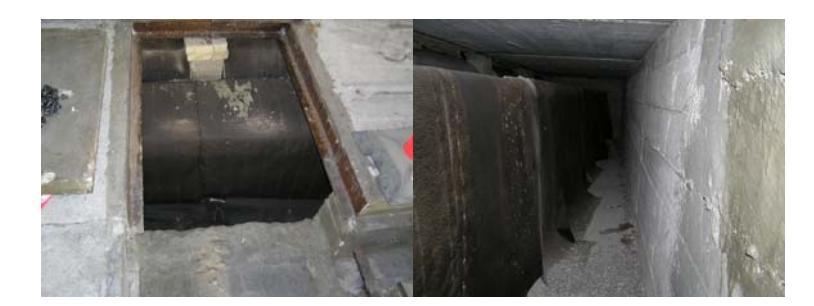
The channels for the ventilation ducts had been covered with concrete and a wooden floor. One access hole to the channels was situated in the northern channel for the pipes leading to the fission gas station and another access hole in the southern channel for electric cables. It was assumed that if any contamination was to be found in these channels it would be close to the access holes. Therefore, the areas in the channels around the access holes were measured with a contamination monitor CoMo 170 No. DD5. No contamination was found. Fig. 21 shows the wall behind one of the ventilation grills and Fig. 22 shows one of the channels with the ventilation ducts.

Figure 22. One of the channels with the ventilation ducts. To the left, the access to the channel is shown. To the right, the channel is seen. The channel has a height of 90 cm.

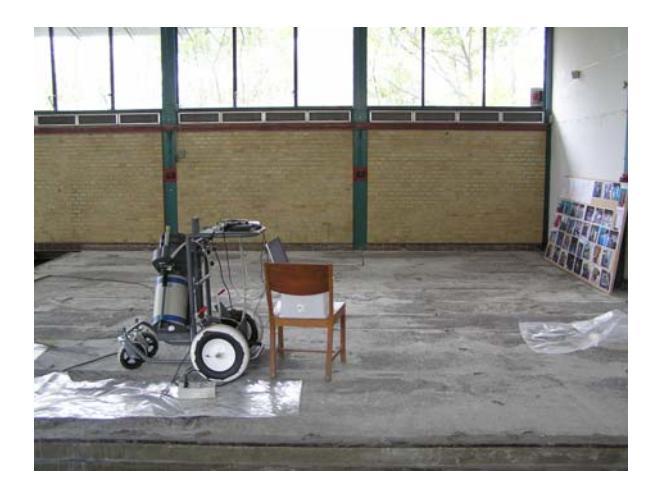
The rest of the walls were measured with Ge-detectors B5064 and B5053. Each upper wall was measured in two steps, each covering at least half of the wall. The detectors were directed at a point three to four meters below the ceiling. It was conservatively assumed that all the activity seen by the detector was situated in one square meter that was positioned farthest away from the detector. Most likely the contamination will be evenly distributed on the wall and for comparison the average surface concentration has also been determined.

Figure 24. The detector is pointing at the western upper part of the southern wall.

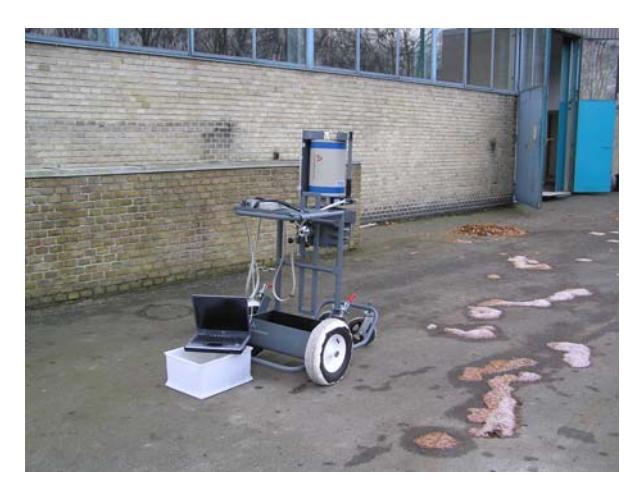
One measurement was made with a Ge-detector on the asphalt area. A background spectrum was measured at a Risø area with a similar type and age of asphalt. No radionuclides resulting from the operation and decommissioning of DR 1 was found in the measurement on the asphalt in front of the DR 1 building.

Figure 30. Gamma-spectrometric measurement at the asphalt area north of the building.

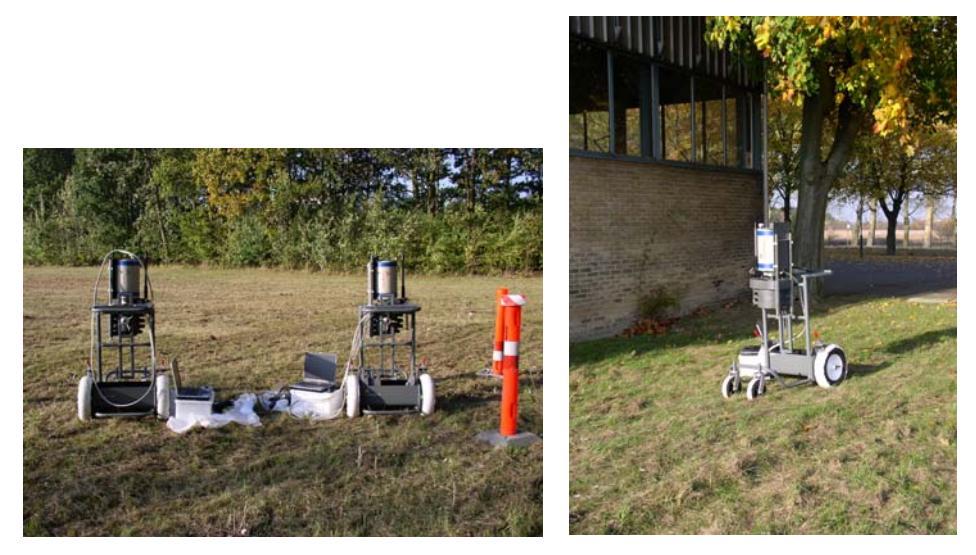
Figure 31. Gamma-spectrometric measurement of the background the area east of the DR 1 building.

Again, no contamination resulting from the reactor operation and decommissioning was found.
