Industrial radiography incidents in Norway 2014

Sindre Øvergaard, Bjørn Helge Knutsen, Gunnar Saxebøl

Berne, 15.03.2016

Statens strålevern
Norwegian Radiation Protection Authority

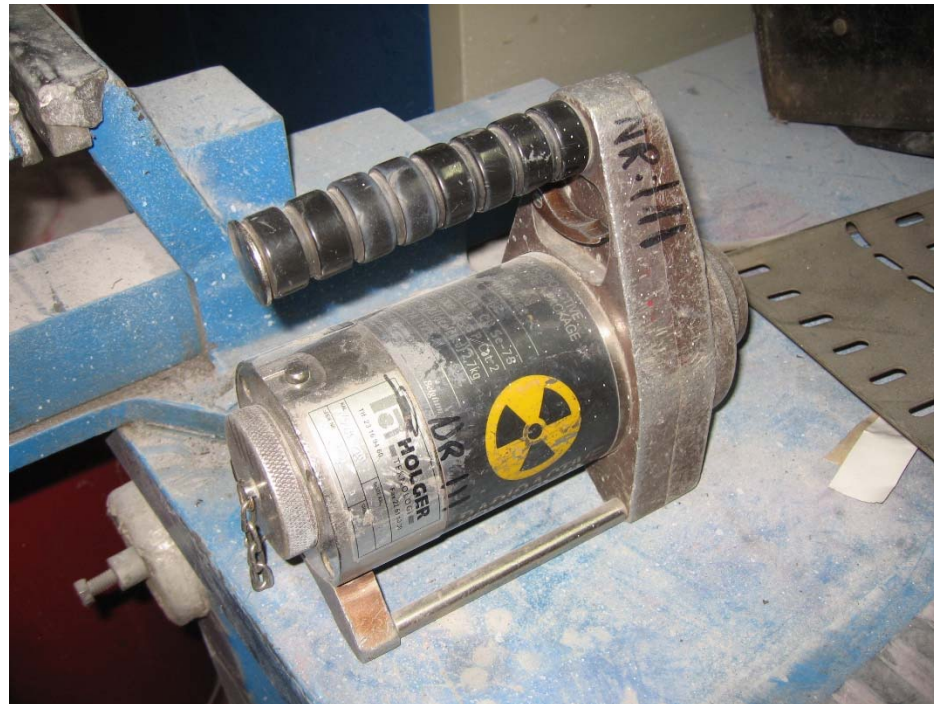
The situation at site:

- Radiography was carried out in a bunker by two radiography operators, using GammaMat Se-75 with associated equipment
