# ALARA learnings of the lost radioactive source in the West Australian outback

Frank Harris Chief Advisor Radiological Governance

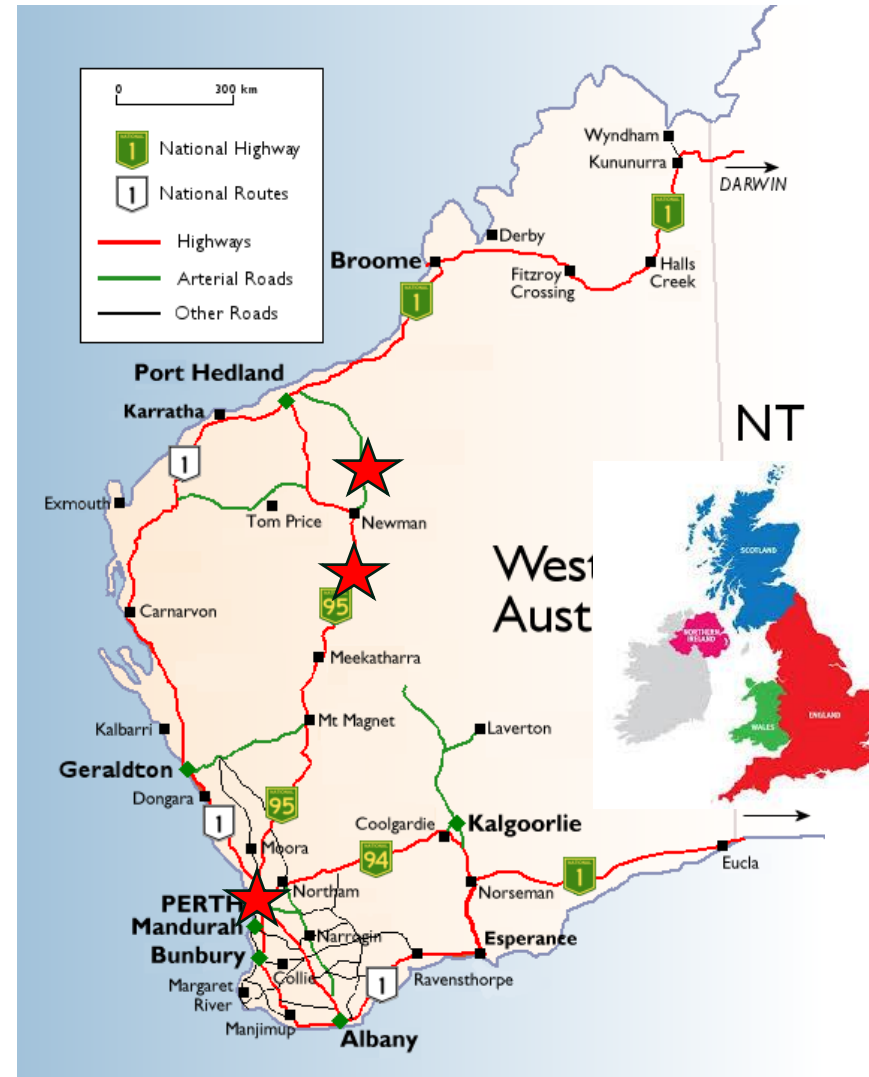
- Initial searching of major transport points such as mine site, loading area, transfer yards using a combination of industry and State resources
- Some targeted searching based on public information
- More specialised instrumentation and teams sourced from Commonwealth agencies (ANSTO, ARPANSA and Defence)
- Larger and more sensitive detectors enable the speed of search to be greatly increased with a higher probability of source location

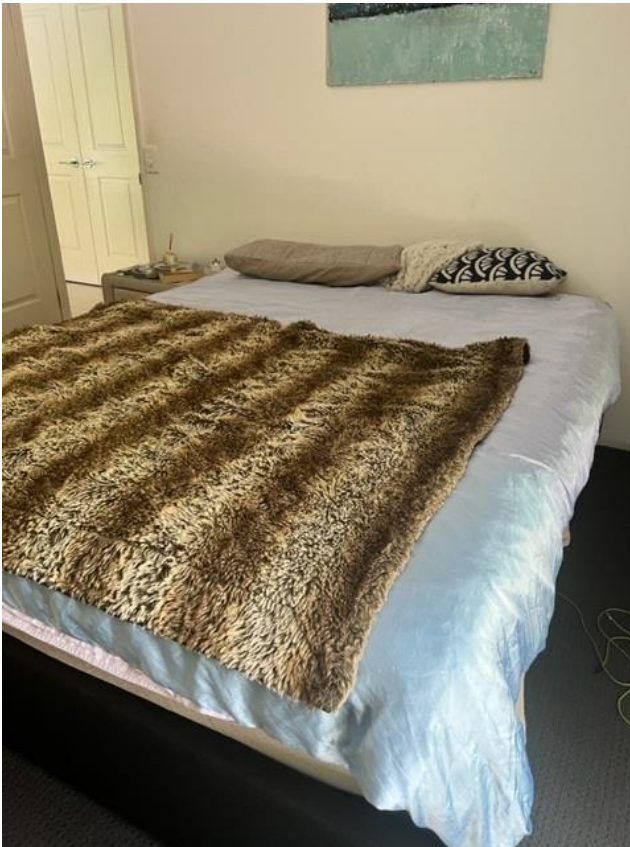
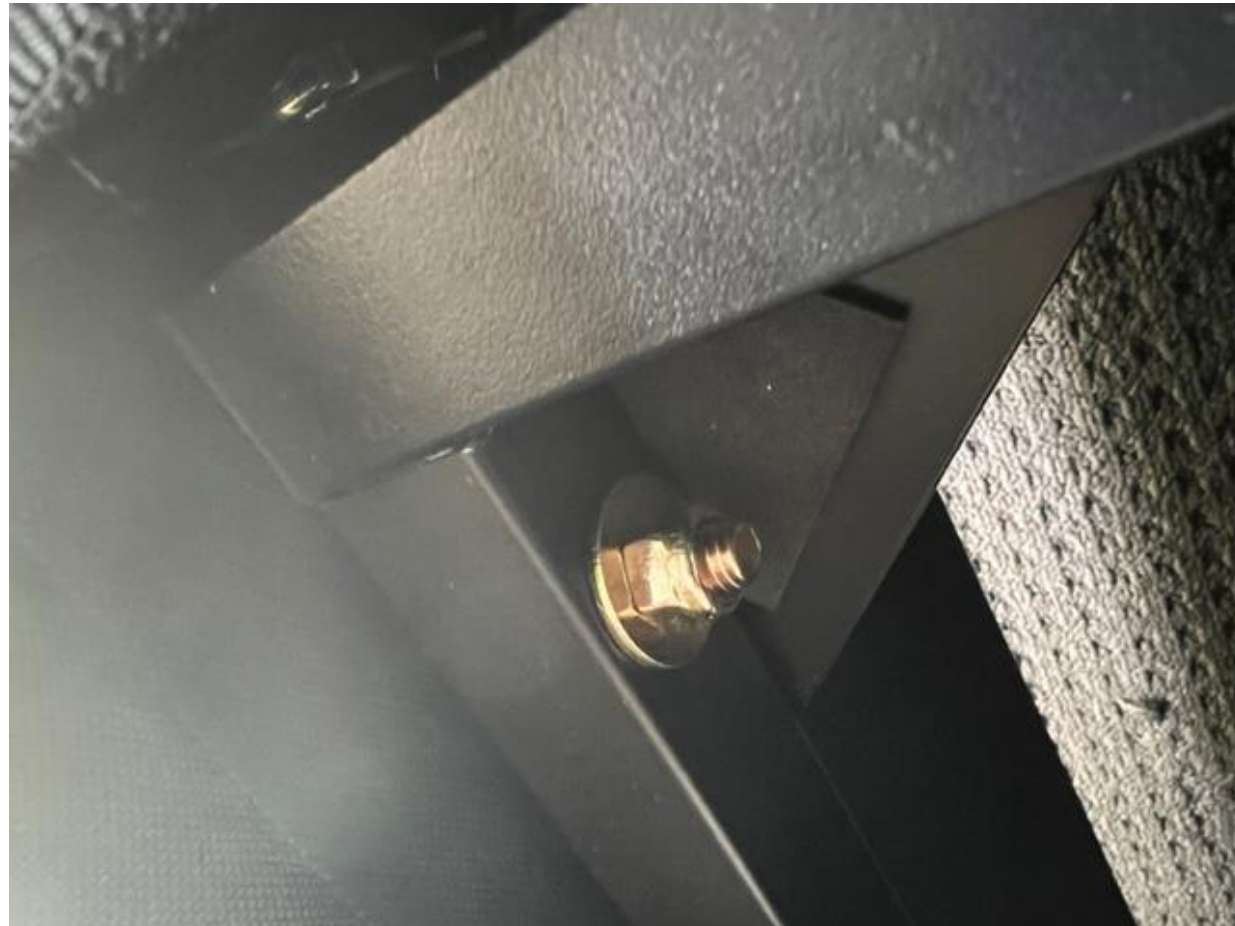
# Vibration!!!!!!

- Vibration is a well known potential cause of failure in mechanical components where screws or bolts are used
- Even common items which may be exposed to vibration are protected
