# **Final survey report for DR 1**

## **Clearance of building and land**

**Danish Decommissioning, Roskilde**  
**December 2005**

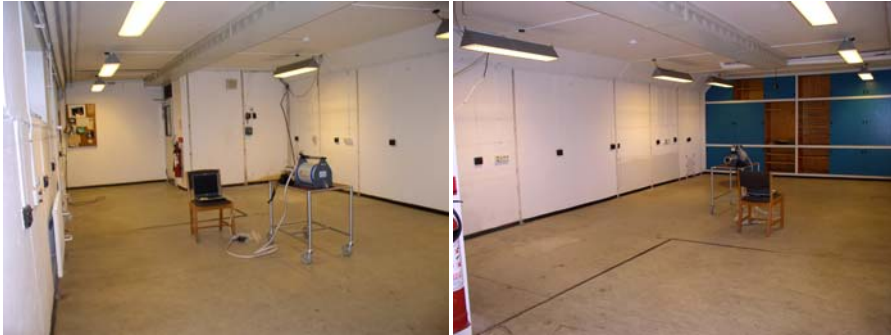
dionuclides as well as  $^{137}\text{Cs}$  from nuclear weapons fall-out and from the Chernobyl accident. As  $^{137}\text{Cs}$  is one of the radionuclides, which could be a contaminant from the operation of the reactor, a background spectrum was measured in a private basement outside the Risø-area. This background spectrum was subtracted from the spectrum measured in the counting laboratory to determine if the operation or the decommissioning of the reactor had caused any contamination in the laboratory. No contamination was found.

Figure 13. Measurement in the counting laboratory with the Ge-detector B05053.

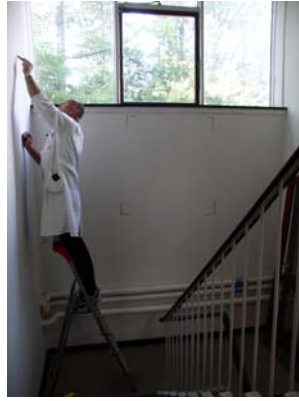
The stairs were measured with contamination monitors CoMo 170 No. DD5 and CoMo 300 No. 6694. The walls along the stairs were measured to a 100% coverage to a height of one meter. On the remaining part of the walls, three surfaces, each of one square meter, were randomly chosen and measured with a contamination monitor CoMo 300 No. 6694. No contamination was found. Fig. 14 shows the marking of the wall.

*Figure 14. A surface of one square meter is marked on the wall of the stairway.*

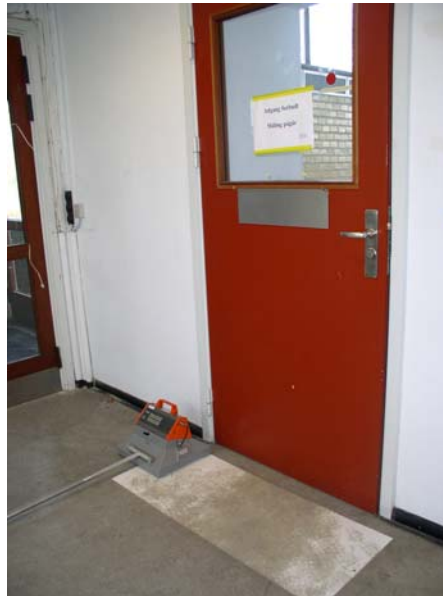
The landing at the first floor was measured to a nearly 100 % coverage. The floor was measured with a contamination monitor Thermo Delta 5 No. DD10, and the walls, doors, ceiling, and ventilation pipe were measured with a contamination monitor CoMo 170 No. DD5. No contamination was found. The wall behind the ventilation pipe and the ceiling over the ventilation pipe were not measured. Figure 15 shows the measurement on the floor with the contamination monitor Thermo Delta 5.

*Figure 15. The measurement of the floor at the upper landing of the stairway.*

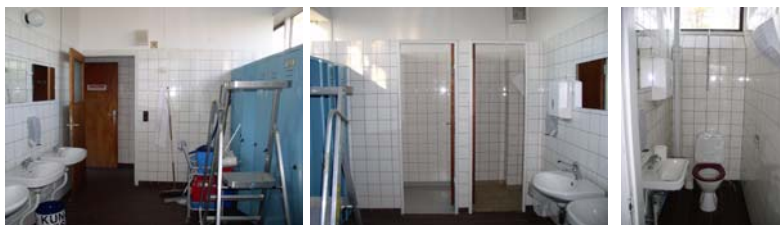
The walls, the ceiling, the floor, and all objects in the locker room were measured for contamination with contamination monitors CoMo 170 No. DD5 and DD21. No contamination was found.

In the toilet, the floor, the door, the walls, the toilet and other objects were measured for contamination with a CoMo 170 No. DD5. No contamination was found.

Figure 16. The locker room and the toilet at the first floor.

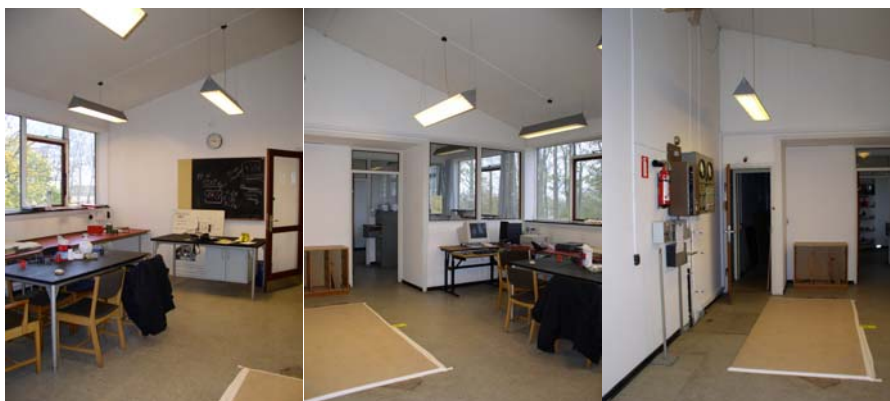
Although the control room is regarded as a class 2 area it was measured to a nearly 100% coverage. The floor was measured with a contamination monitor Thermo Delta 5 No. DD10. The walls, the ceiling, the doors, the window sills, the different objects and the furniture and fixtures were measured with a CoMo 170 No. DD5. No contamination was found.

Figure 17. The control room seen from different angles.

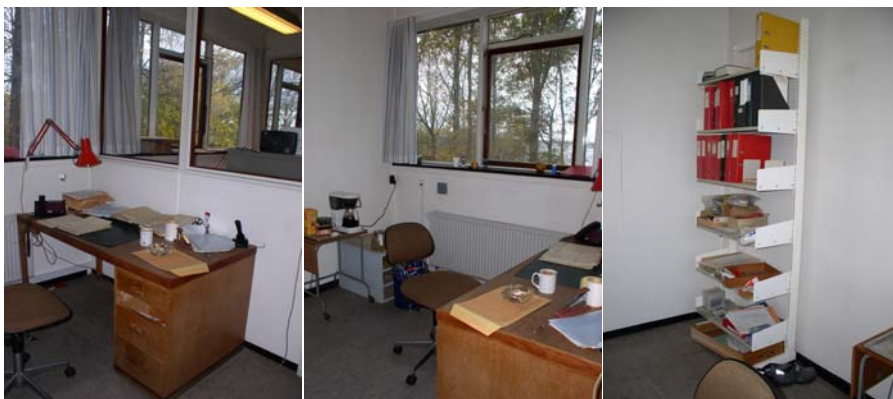
Figure 19. Office No. 1.

Although classified as a class 2 area, the room was checked for contamination to a nearly 100 % coverage. The floor was measured to a 100 % coverage with a Thermo Delta 5 No. DD10 contamination monitor. The walls, window sills, ceiling, objects, papers and furniture were measured with a contamination monitor CoMo 170 No. DD5. No contamination was found. Fig. 19 shows the office.

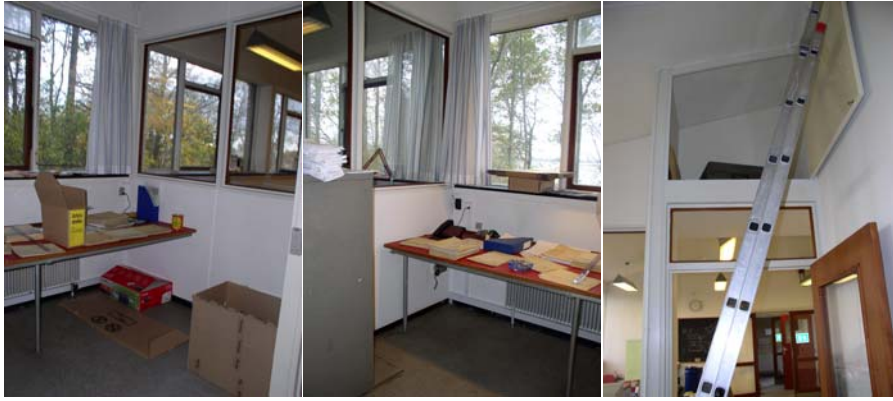
Figure 20. Office No. 2.

Although classified as a class 2 area, the room was checked for contamination to a nearly 100 % coverage. The floor was measured with a Thermo Delta 5 No. DD10 contamination monitor. The walls, window sills, ceiling, objects, papers and furniture were measured with a contamination monitor CoMo 170 No. DD5. No contamination was found. Fig. 20 shows the office.

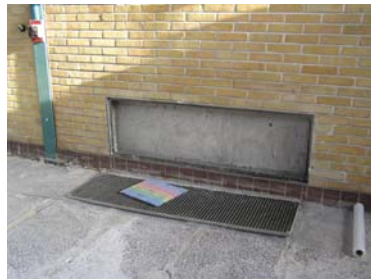
The ducts for the heating system are not accessible. It was assumed that if any contamination was to be found in the ducts, it could be detected behind the ventilation grills of the outlet from the hall. The wall behind the grills were measured with contamination monitor CoMo 170 No. DD5. No contamination was detected. Some dust behind the ventilation grills was scraped off the wall and analysed by gamma-spectrometry in the laboratory. The sample showed small amounts of <sup>137</sup>Cs and <sup>60</sup>Co. Assuming conservatively that there was a dust covering of half a kilogram at each square meter, the surface contamination of <sup>137</sup>Cs would be less than 1500 Bq/m<sup>2</sup> and less than 200 Bq/m<sup>2</sup> for <sup>60</sup>Co. It was therefore concluded, that the contamination of the ducts would be far below the clearance levels.

Figure 21. The heating air outlet from the reactor hall. The ventilation grills have been removed for measurements behind the grill and in the ducts.

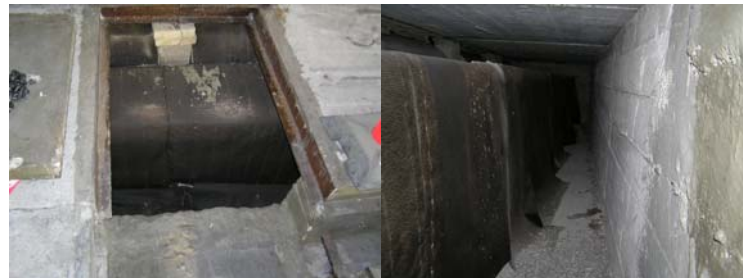
The channels for the ventilation ducts had been covered with concrete and a wooden floor. One access hole to the channels was situated in the northern channel for the pipes leading to the fission gas station and another access hole in the southern channel for electric cables. It was assumed that if any contamination was to be found in these channels it would be close to the access holes. Therefore, the areas in the channels around the access holes were measured with a contamination monitor CoMo 170 No. DD5. No contamination was found. Fig. 21 shows the wall behind one of the ventilation grills and Fig. 22 shows one of the channels with the ventilation ducts.

Figure 22. One of the channels with the ventilation ducts. To the left, the access to the channel is shown. To the right, the channel is seen. The channel has a height of 90 cm.

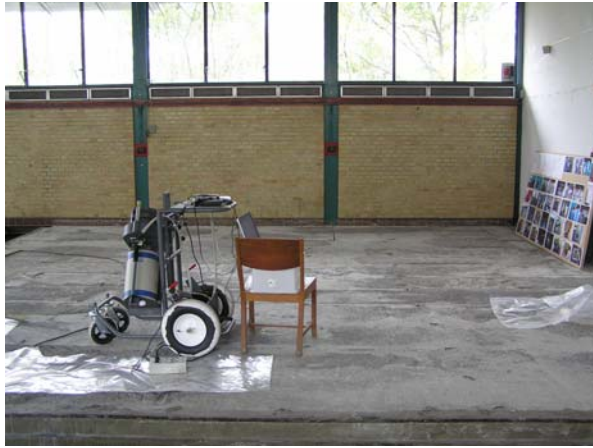
The rest of the walls were measured with Ge-detectors B5064 and B5053. Each upper wall was measured in two steps, each covering at least half of the wall. The detectors were directed at a point three to four meters below the ceiling. It was conservatively assumed that all the activity seen by the detector was situated in one square meter that was positioned farthest away from the detector. Most likely the contamination will be evenly distributed on the wall and for comparison the average surface concentration has also been determined.

*Figure 24. The detector is pointing at the western upper part of the southern wall.*

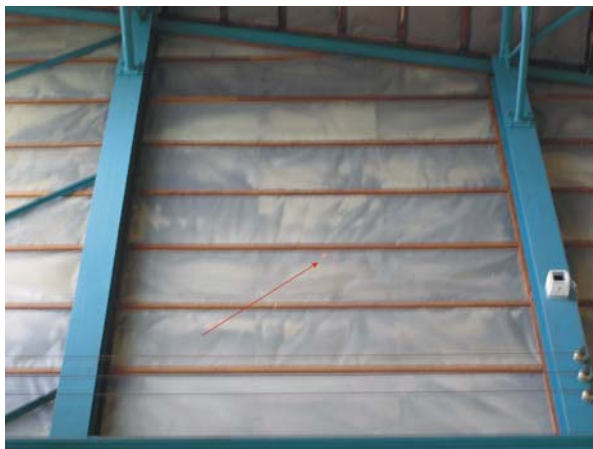
*Figure 26. A laser beam is used to position the detector at the western part of the northern wall.*

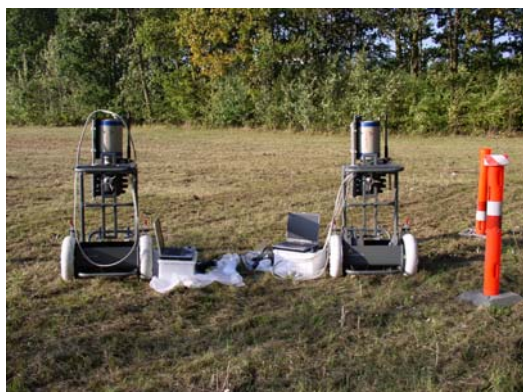
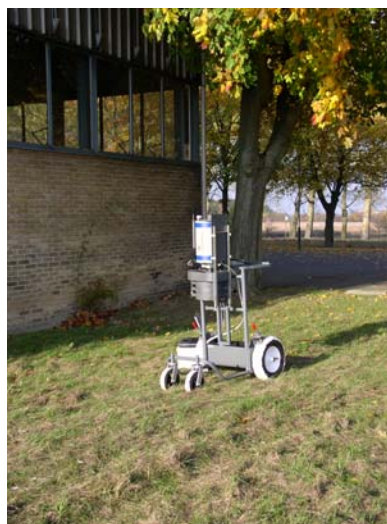
*Figure 31. Gamma-spectrometric measurement of the background the area east of the DR 1 building.*

Again, no contamination resulting from the reactor operation and decommissioning was found.
