THE RADIOACTIVE INCIDENT OF ACINEROX IN SPAIN

J.T. Ruiz, J.M. Campayo (LAINSA)

European ALARA Newsletter – Issue 8

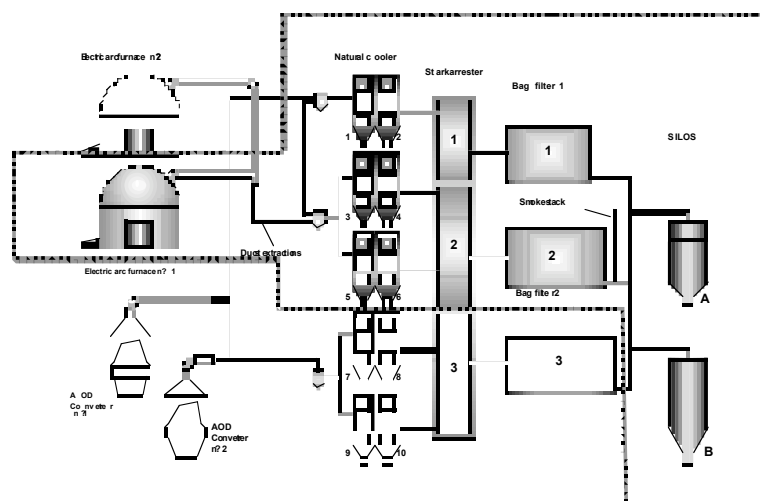
Figure 1. Contaminated facilities

Since the very beginning the contamination had affected the smoke dust that circulates through the conduits of the gas extraction system of the electrical arc furnace n° 1 and to the shared clearing system for furnaces n° 1 and n° 2 (Figure 1).
